**Assessment of the long-term response to rehabilitation of two wetlands in
KwaZulu-Natal, South Africa.**

**Thesis submitted in fulfilment of the requirement for the degree of Master of Science in
Environmental Science, Rhodes University, Grahamstown.**

**Craig Cowden
612C0005**

January 2018

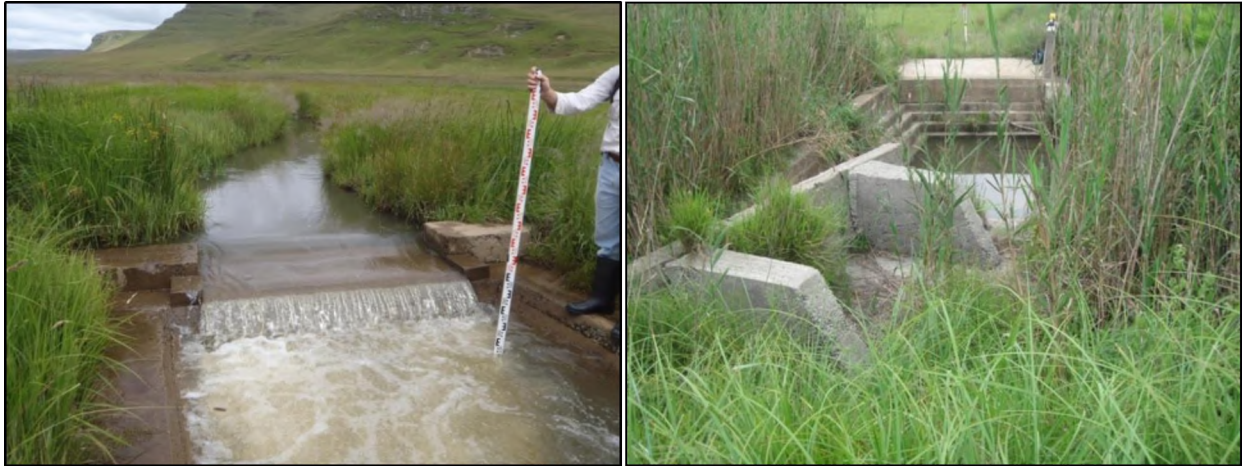
Plate 3.1. Concrete weir in the main channel of the Killarney (left) and Kruisfontein (right) wetlands.

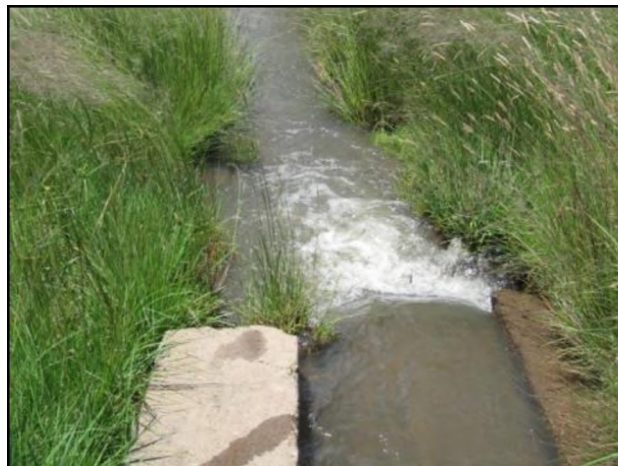
Plate 3.2. A spreader canal diverting a portion of the base flows out of the main channel in the Killarney wetland

A single spreader canal was constructed across the upper portion of the wetland to divert a portion of the base flows out of the main channel upstream of a concrete weir intervention. The spreader canal allowed for a continual supply of water to be available for improving the hydrology within the wetland area adjacent to the main channel. The site inspection revealed that the end of the spreader canal had breached and the majority of the water was flowing out of the end of the canal rather than being spread across the wetland. The water that was being discharged at the end of the spreader canal was flowing into a secondary channel on the right hand side (facing downstream) of the wetland. The point of entry of the water into the secondary channel was showing signs of erosion with the development of numerous small nick points. Plate 3.5 shows the erosion developing as a result of flows originating from the spreader canal.

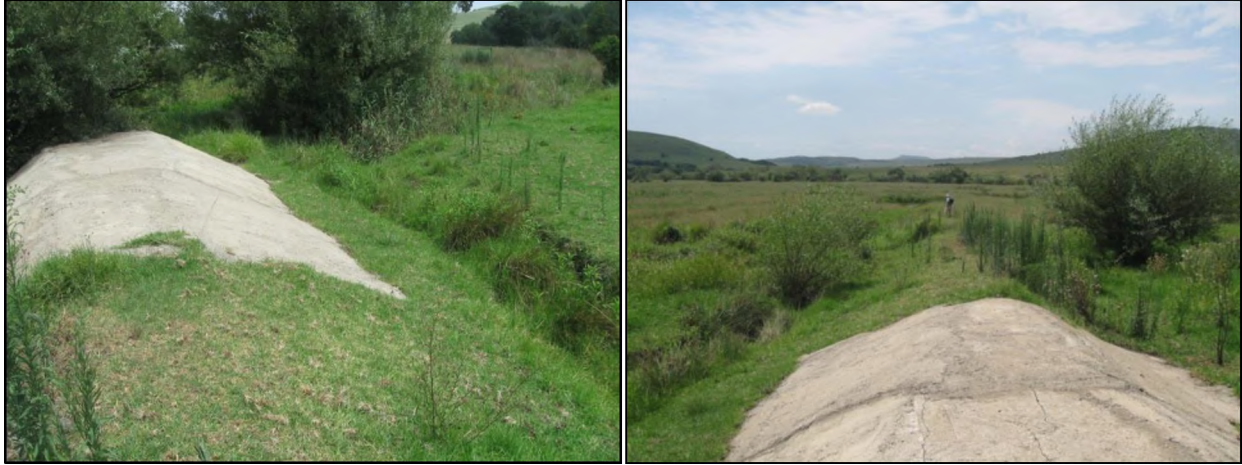
Plate 3.3. A concrete-covered earthen berm diverting flows out of the main channel in Kruisfontein wetland

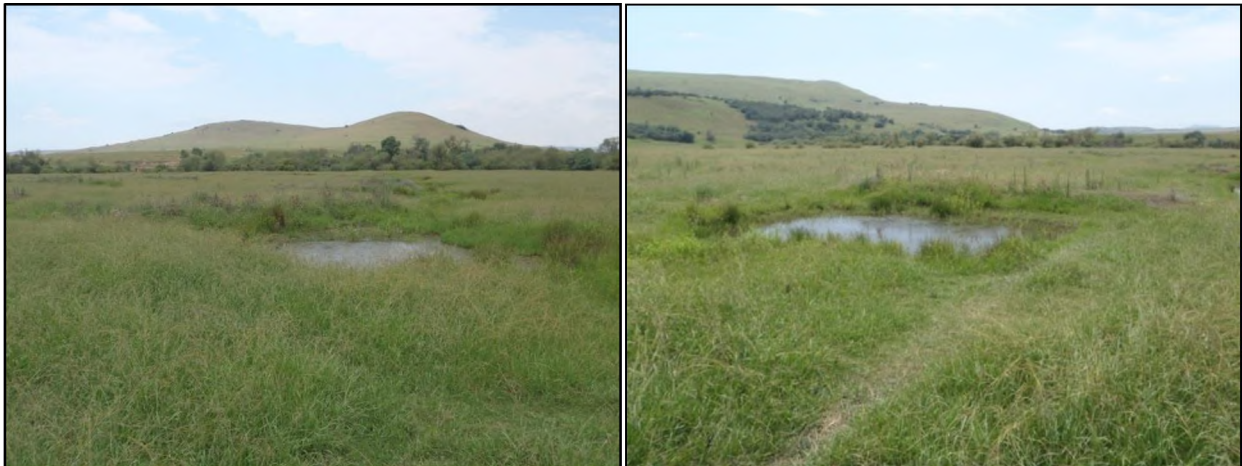
Plate 3.4. A series of earthen berms used to deactivate the ridge-and-furrow drainage in Kruisfontein wetland.

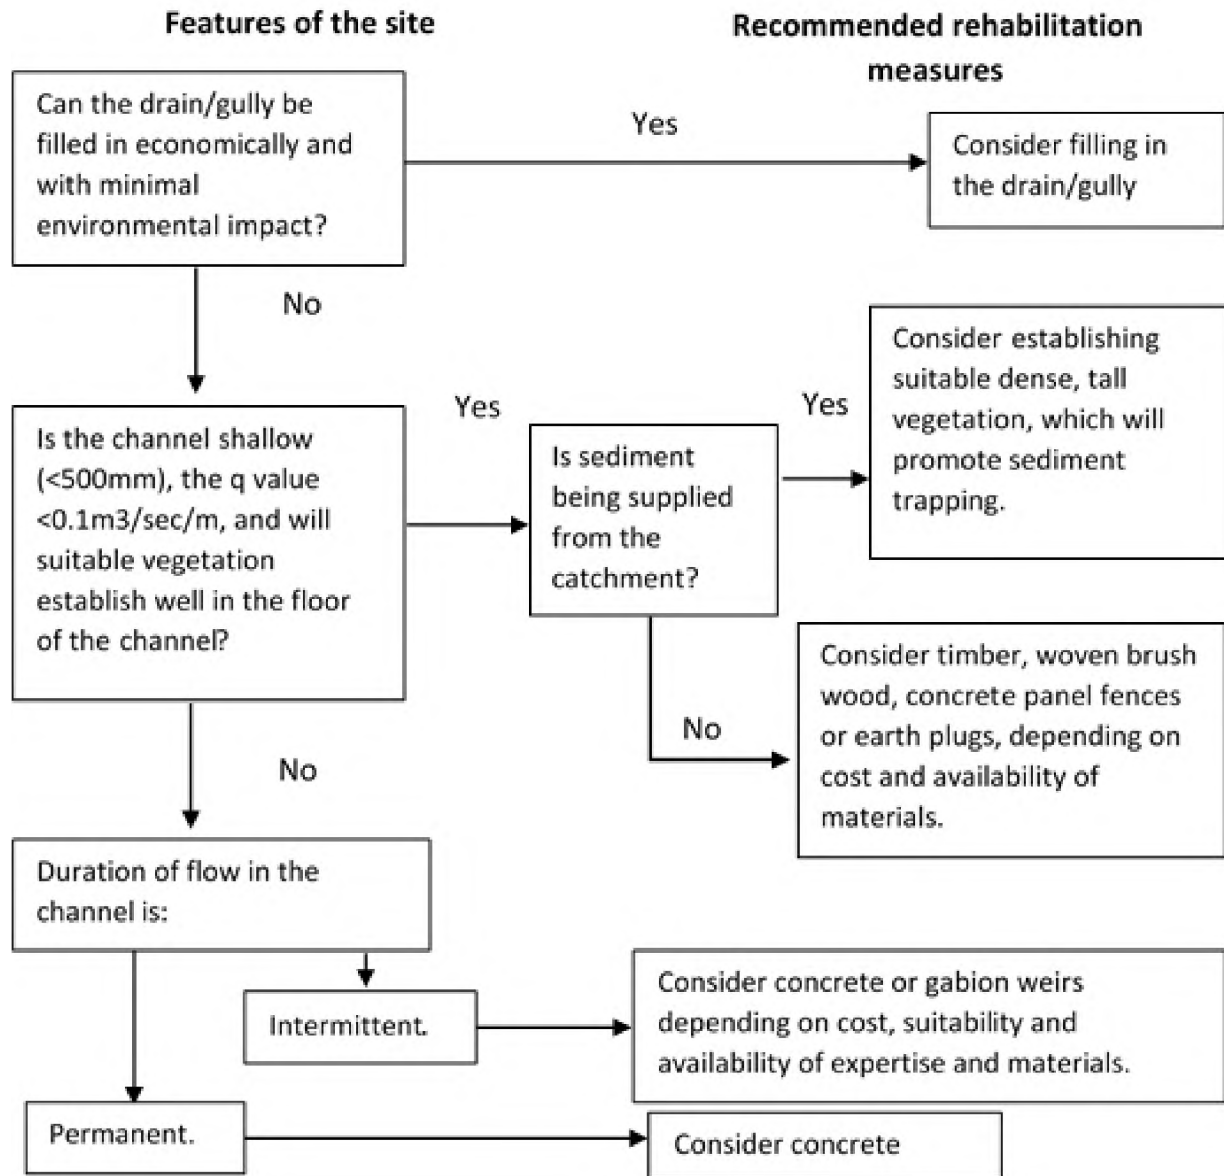
To provide a guide for assessing whether the various structural interventions within the two wetlands were appropriate for the particular setting onsite, the WET-RehabMethods (Russell 2009) decision tree for the selection of appropriate rehabilitation measures to address erosion gullies and/or drainage channels in wetlands (Figure 3.1) were applied for both sites.

Figure 3.1. Decision tree for choosing appropriate rehabilitation interventions for erosion gullies and drainage canals in wetlands (Russell 2009, p.35)

The application of the WET-RehabMethods decision tree (Figure 3.1) confirmed that the earthen and concrete interventions adopted for the rehabilitation of the Killarney and Kruisfontein wetlands, were used in appropriate settings (Appendix 2). Based on field observations, minor issues relating to construction rather than ‘catastrophic failure’ of the interventions, were identified at both wetlands (Appendix 2). It appears that the adoption and implementation of available guidelines and best practice during the planning and design phase assisted in the low failure rate recorded at these sites. However, discrepancies relating to the construction phase, especially relating to the dimensions of the constructed interventions were identified (Appendix 2), but can be easily addressed with the implementation of maintenance.

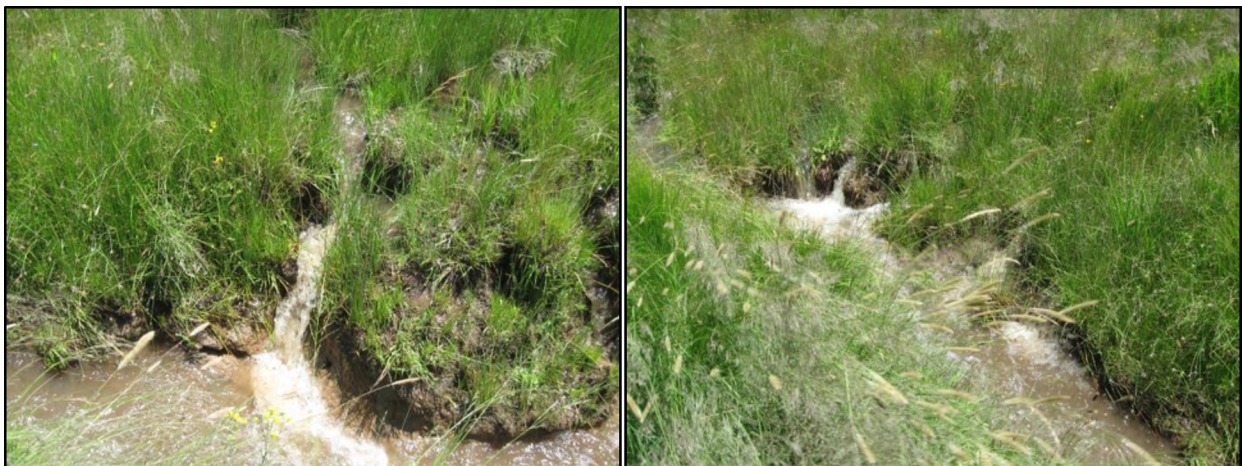
Plate 3.5. Photographs showing the development of erosional nick points where water from the spreader canal enters the secondary channel

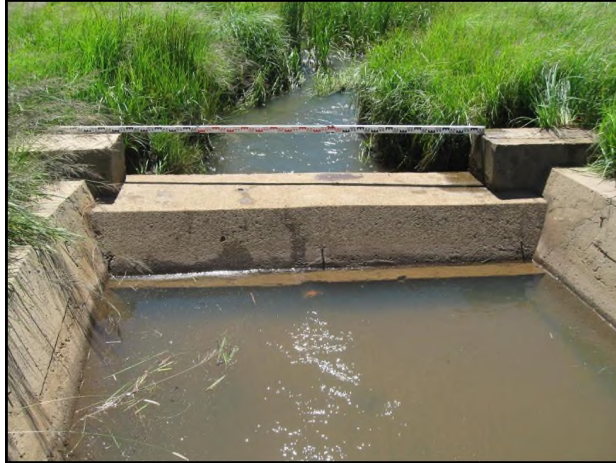
The investigation of the structural integrity of the concrete weirs identified only one of the seventeen weirs as requiring maintenance, where tunnelling had occurred (Plate 3.6), which directly affects the likelihood of the intervention achieving the specified objectives. A number of interventions appear to have been modified, with the overflow / spillway wall having been lowered to account for deviations from the plan during implementation. In addition, a number of issues relating to implementation were identified, e.g. 'honeycombing' of concrete, limited freeboard, key walls incorrectly constructed. However, the modifications to the interventions were not impacting on the integrity of the interventions, and should be monitored during future site visits to ascertain if corrective measures may be required in future. Although serving to redistribute flows from the main channel, the spreader canal was identified as requiring corrective measures, mainly in order to address the breaching of the canal's endpoint. Currently, flows are unequally distributed across the spreader canal's length and concentrated flows are entering a secondary channel initiating erosion, as described in the previous section. The earthen berms within the lateral drain were considered to be built in an appropriate setting in accordance with the plan, and they appeared stable and well-vegetated, with no corrective measures identified.

Plate 3.6. View from downstream of an intervention in the Killarney wetland with no water flowing over the spillway as a result of tunnelling that has occurred allowing base flows to pass under the structure.

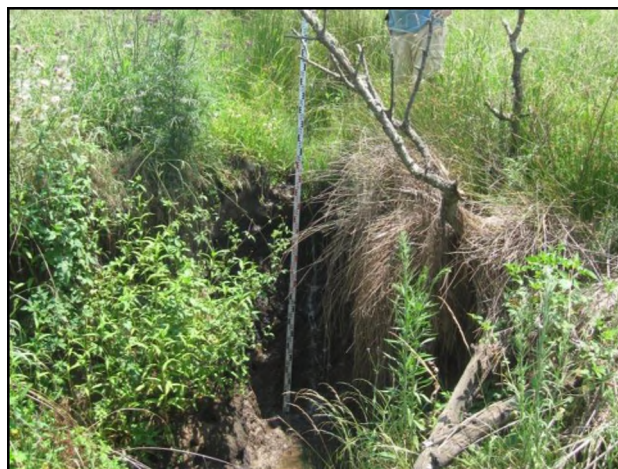
The deactivation of the ridge-and-furrow drainage network was in the form of a series of earthen plugs that were constructed across the furrow portions. The deactivation of the ridge-and-furrows has had limited success as flows were not being diverted in a diffuse manner across large portions of the wetland. Despite flows being more diffuse than previously, a preferred flow path has developed along the furrows and consequently a smaller portion of the wetland has been positively influenced by the rehabilitation than planned. Further interventions will be required to successfully deactivate the ridge-and-furrow drainage network and the erosion that initiated where the preferred flow path enters the Mooi River (Plate 3.7)

Plate 3.7. Headcut erosion as a result of concentrated flows discharging over the bank of the Mooi River

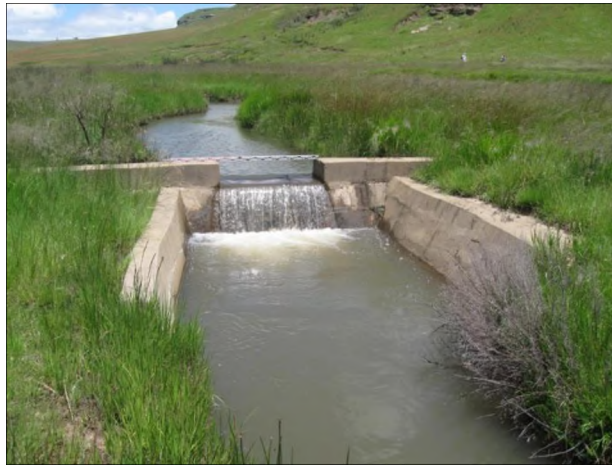
interventions back-flooding halfway up the interventions upstream (Plate 3.8). Currently, the same cannot be said for the interventions within the Kruisfontein wetland as flows have not exceeded the design specifications, although the interventions have withstood elevated flows.

Plate 3.8. View of water back-flooding to the base of an intervention in Killarney wetland
