**GEOMORPHOLOGICAL CONNECTIVITY AND SENSITIVITY  
EXAMINED IN A RECENTLY DEGRADED GRAVEL-BED STREAM:  
IMPLICATIONS FOR RIVER-FLOODPLAIN REHABILITATION**

A thesis submitted in fulfilment of the requirements for the

**DOCTOR OF PHILOSOPHY**

**RHODES UNIVERSITY**

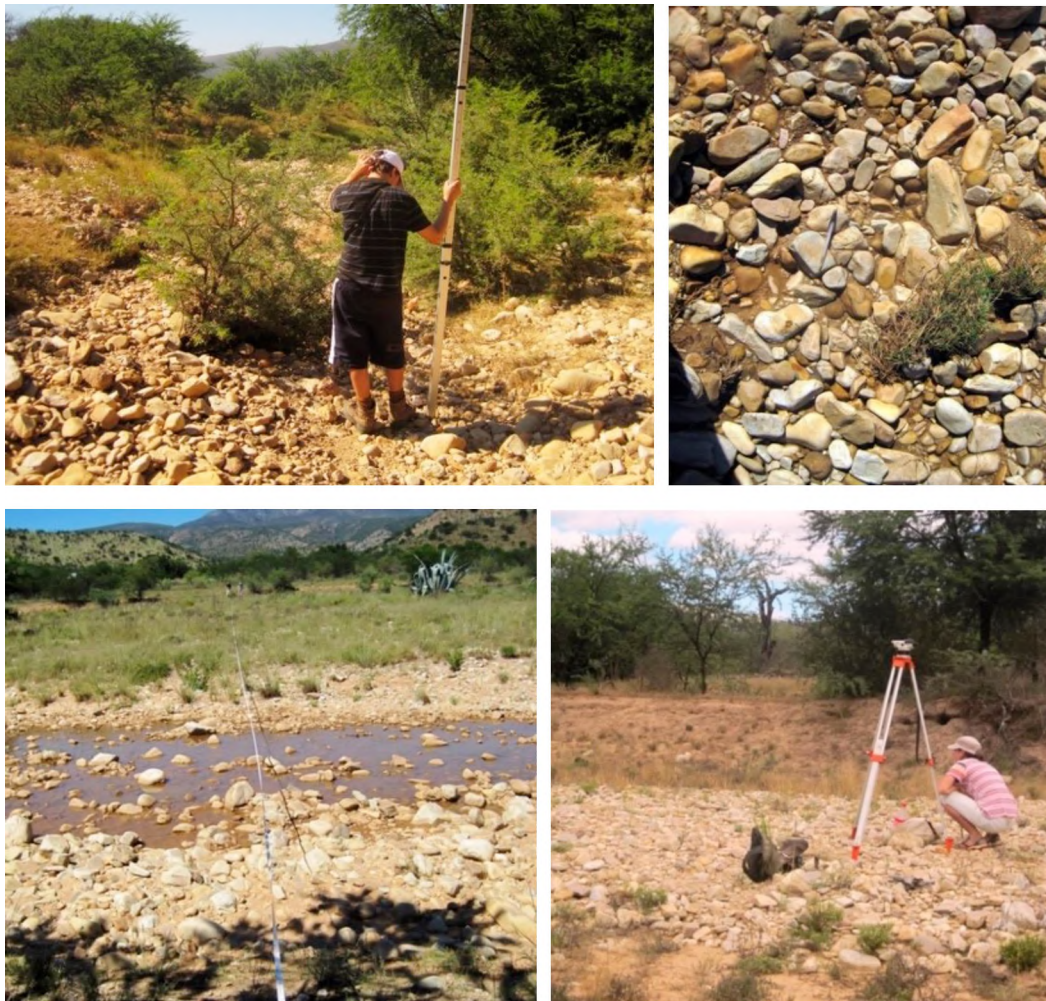
**Plate 3.1:** Large boulders are commonly encountered along the bed of the Baviaanskloof River along most of the upper- to middle-reaches, including the study reach.

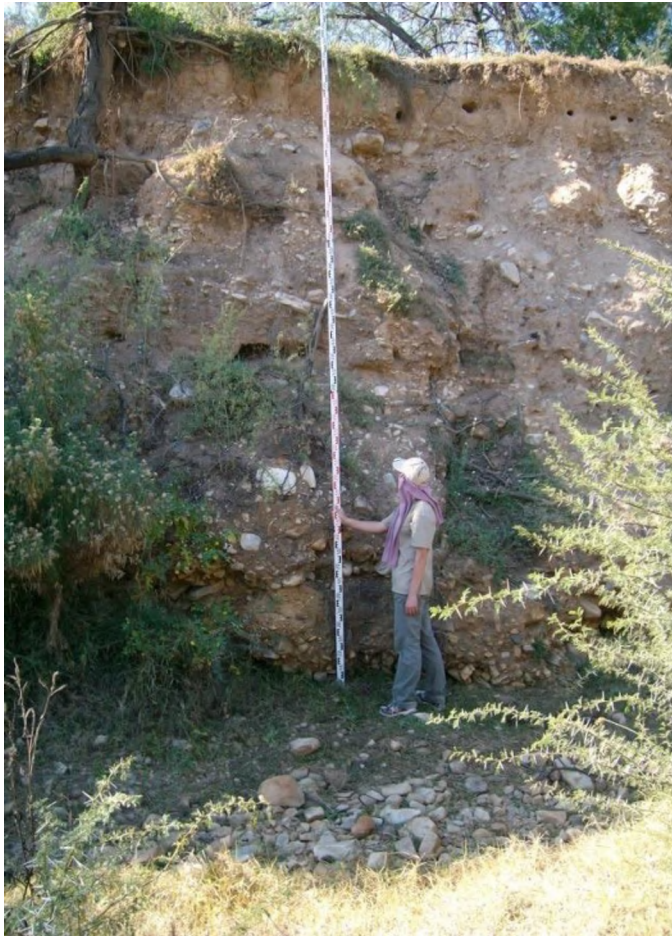
**Plate 4.4:** A deeply eroded toe of an alluvial fan that impinges on the left bank of the trunk channel producing an incised bank of approximately 6 m deep.

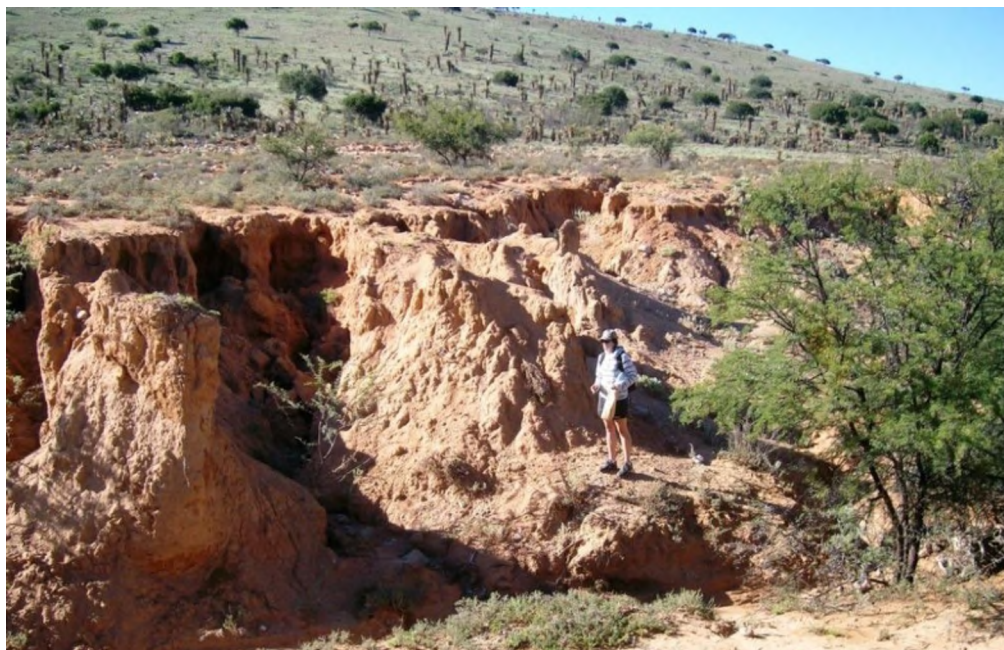
**Plate 5.1:** An example of a deeply entrenched, relatively stable hillslope gully located on the southern foothills of the study reach.

The timing of land cover changes described above often coincided with the formation of several hillslope gully systems on the southern side of the valley. Analysis of aerial imagery suggests that the gullies were shallow, discontinuous hillslope channels during the 1960s, when stocking and browsing of hillslope vegetation was already high. By 1986 these minor hillslope channels had expanded into relatively wide and deep gully networks, coinciding with the timing of intensive stocking of the valley with Angora goats due to the boom in the Mohair market. Between 1986 and 2009 the morphology of the gullies appears to have remained relatively stable. The gullies today exist as deeply entrenched features of the landscape, but appear to be relatively stable as indicated by vegetation growth on the gully bed and on gently sloping banks (Plate 5.1).

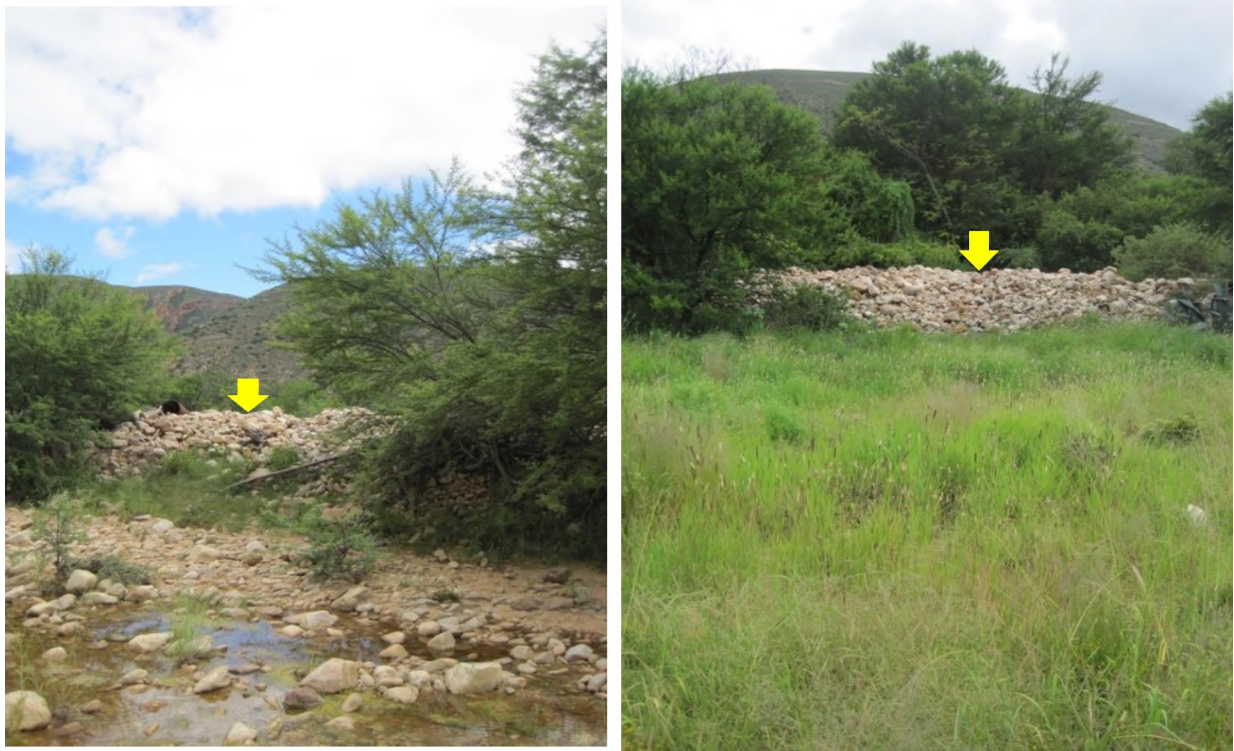
**Plate 5.2:** Examples of earthen berms, indicated by the arrows, that are common throughout the study reach.

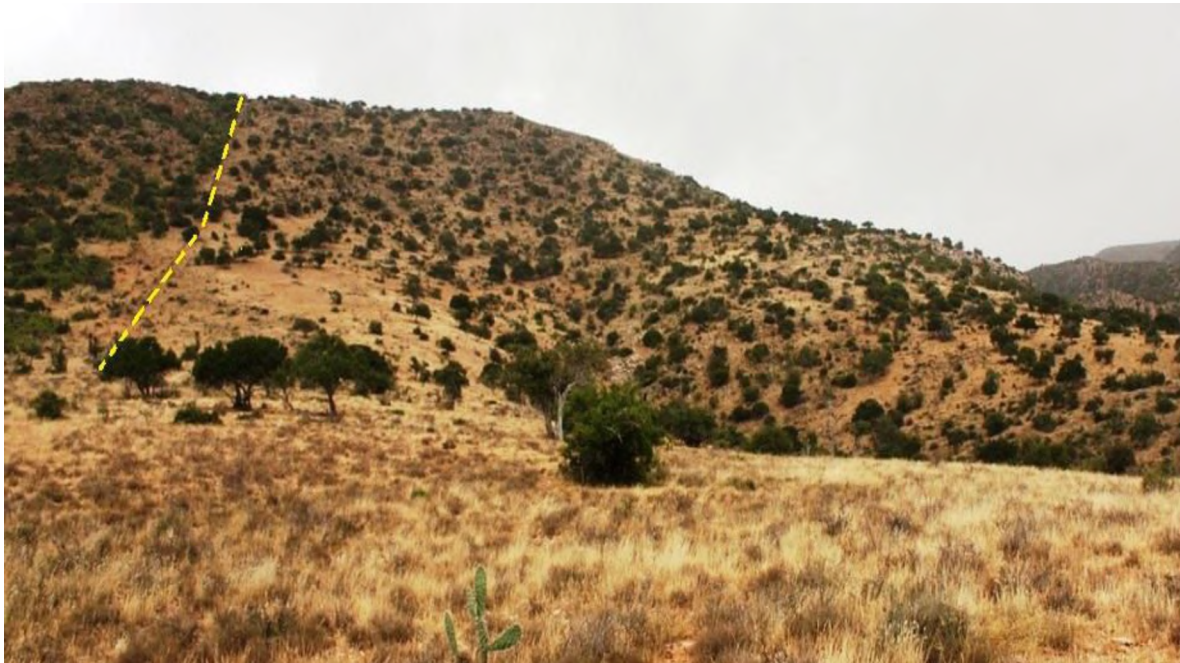
**Plate 5.3:** Degraded subtropical thicket vegetation on the southern side of the valley. Different grazing pressures are visible on either side of the fence line indicated by the yellow dotted line (Photos by B Robb 2012).

The vegetation on the hillslopes of the study reach usually forms a dense, canopy layer where it is in pristine to near-pristine condition (Mills et al. 2007). The once-thick canopy cover has been transformed to scattered trees and shrubs on hillslopes such that most of the hillslope vegetation along the study reach has been classed as moderately to severely degraded (Euston-Brown 2006; Vlok 2010; Plate 5.3). Vegetation degradation has been attributed to overgrazing, largely in the form of browsing by goats and sheep. Overgrazing has been preferential to the southern side of the valley (north-facing slopes), partially because the hills are lower sloping and easily accessible by goats and sheep, and historically these slopes contained the highest density of the palatable thicket species, *Portulacaria afra* or 'spekboom' (Powell et al. 2011). It is suggested that most of the hillslope vegetation degradation in the Baviaanskloof occurred between 1960 and 1988 when stocking densities were highest due to a peak in the market for mohair (Angora goat) and sheep wool (J Buckle, pers. comm., August 2013). The vegetation cover on the left of the dotted line in

Plate 5.3 more closely resembles vegetation cover that would have existed along the study reach prior to intensive overgrazing during the 1970s and 1980s.

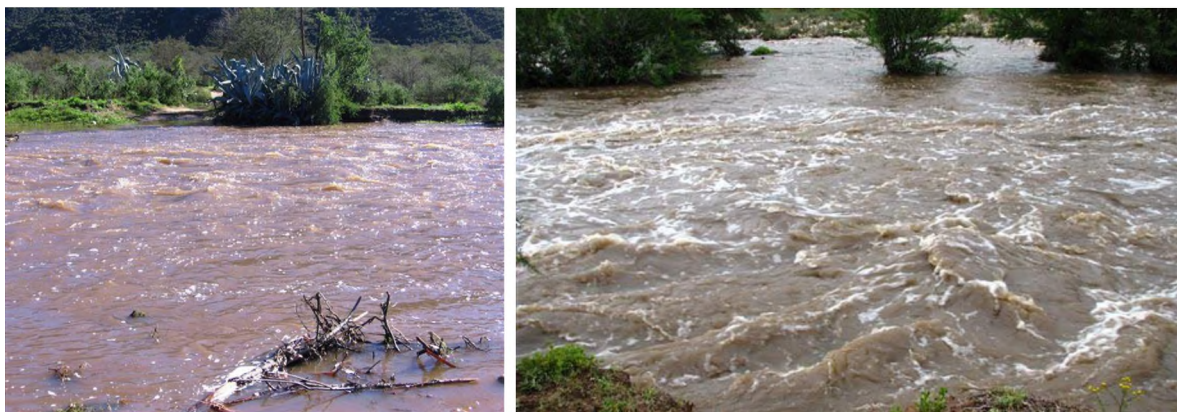
**Plate 5.4:** Sediment laden flood waters during a small flood event in 2012 for a site situated in the middle of the study reach (photos by Hestelle Van Rensburg).

along the study reach, hillslope runoff and erosion would have considerably increased. The degree to which these effects propagate to the trunk channel as increased discharge and sediment delivery is dependent upon the degree of hillslope-channel and tributary-trunk connectivity (Harvey 2002a; Brierley et al. 2006; Fryirs et al. 2007a; Chiverrell et al. 2009). In the Baviaanskloof, there is evidence that high hillslope runoff and sediment erosion is easily transferred to the trunk channel as indicated by dark brown colour of river water during the initial stages of a flood event (Plate 5.4). Interviews with local landowners confirmed that most flood events, whether small or large, are accompanied by sediment laden water that is brown or black in colour (Plate 5.5). Viscous black flood waters are rare but usually associated with an intense storm that follows burning of fynbos vegetation on the mountain slopes of either the Baviaanskloof or Kouga mountains. All of the aforementioned observations indicate high levels of hillslope-channel and tributary-trunk sediment connectivity along the study reach.

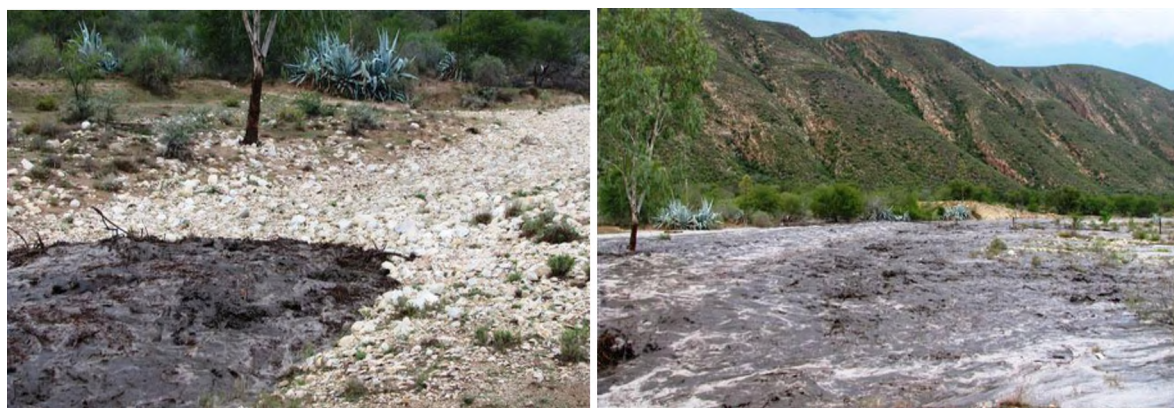
**Plate 5.5:** Charcoal and ash laden river water at the same site as Plate 5.4 during a flood event in 2009. The flood event occurred soon after a mountain fire (photos by Hestelle Van Rensburg).

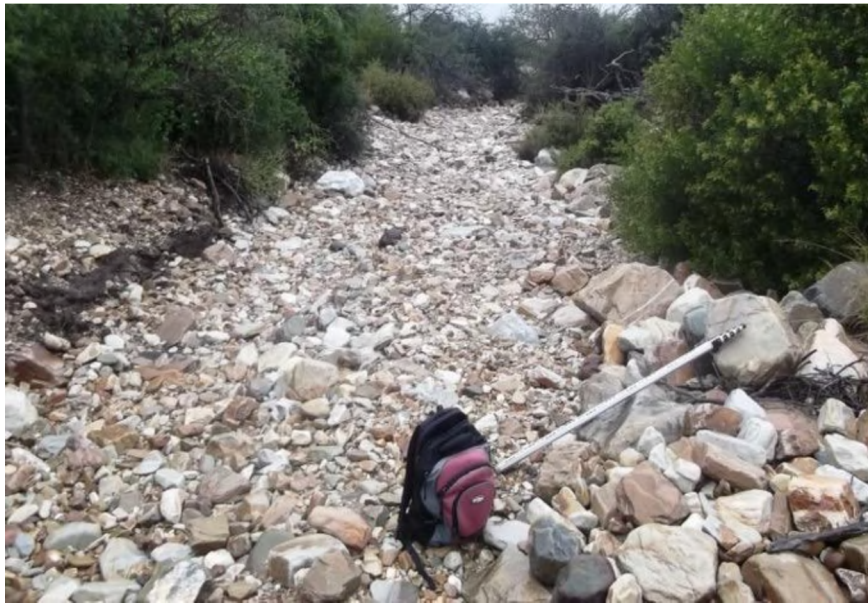
**Plate 6.1:** The coarse nature of sediment on tributary stream beds.

The Baviaanskloof River-floodplain receives considerable amounts of coarse sediment via tributary streams and tributary fans that impinge on the floodplain every few hundred to thousand meters. The channel bed of these tributary streams is characterised by coarse angular grains of mostly pebbles and cobbles, with some boulders indicating high competence and capacity to transfer the coarse sediment from the surrounding mountains during flood events (Plate 6.1). Historically this coarse sediment would have been stored on alluvial fans that formed where streams exit the mountains and enter the valley floor. However, recent fan entrenchment and enhanced tributary-trunk connectivity has diminished the buffering role these fans used to offer along the study reach. Limited understanding of the impacts of tributary-trunk (dis)connectivity on river process, form and sensitivity to change in dryland, gravel-bed streams such as the Baviaanskloof, poses a problem for effectively predicting and managing the impacts of human land-use activities and climate change on these types of systems.

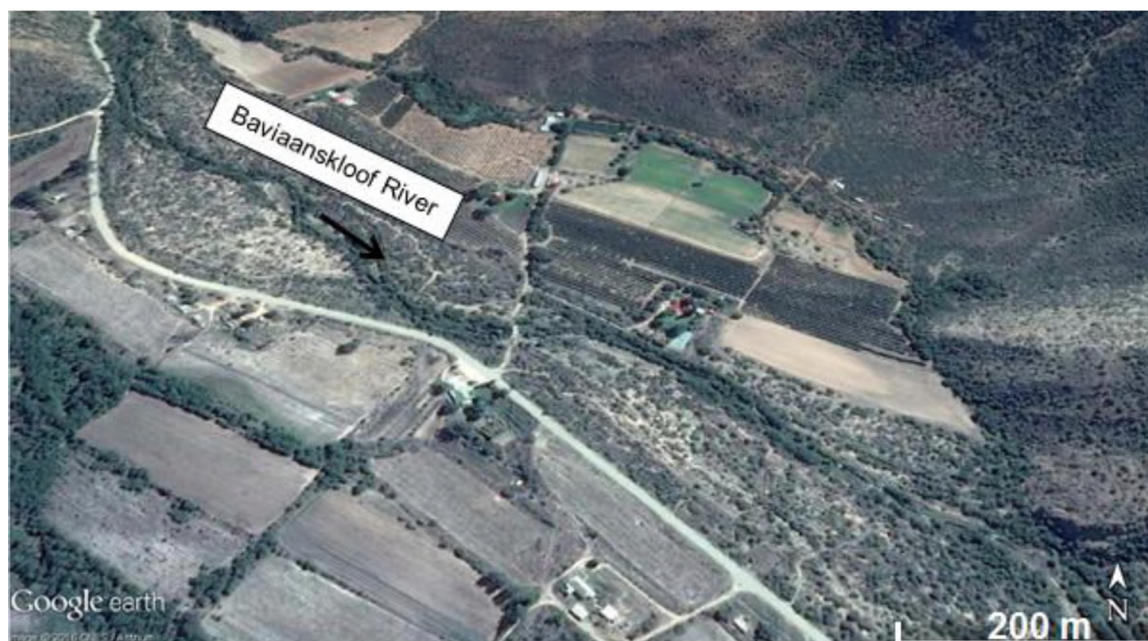
**Figure 6.4:** Example of a transfer river style along the upper-end of the study reach. The arrow indicates direction of flow for the trunk stream.

This style occurs mainly along sub-reach A at the upper-end of the study reach and is dominated by a single thread, narrow and straight channel that is relatively stable, flowing through a narrow valley reach (Figure 6.4). The channel is relatively steeply sloping (average of 0.0072 m/m) and is largely a conduit of sediment to downstream channel reaches during floods, downstream of which sediment is stored in channel bars and on the floodplain. The transfer style has fewest human-made features that influence water and sediment connectivity and space for river adjustment, and represents one of the most stable sub-reaches along the study reach.

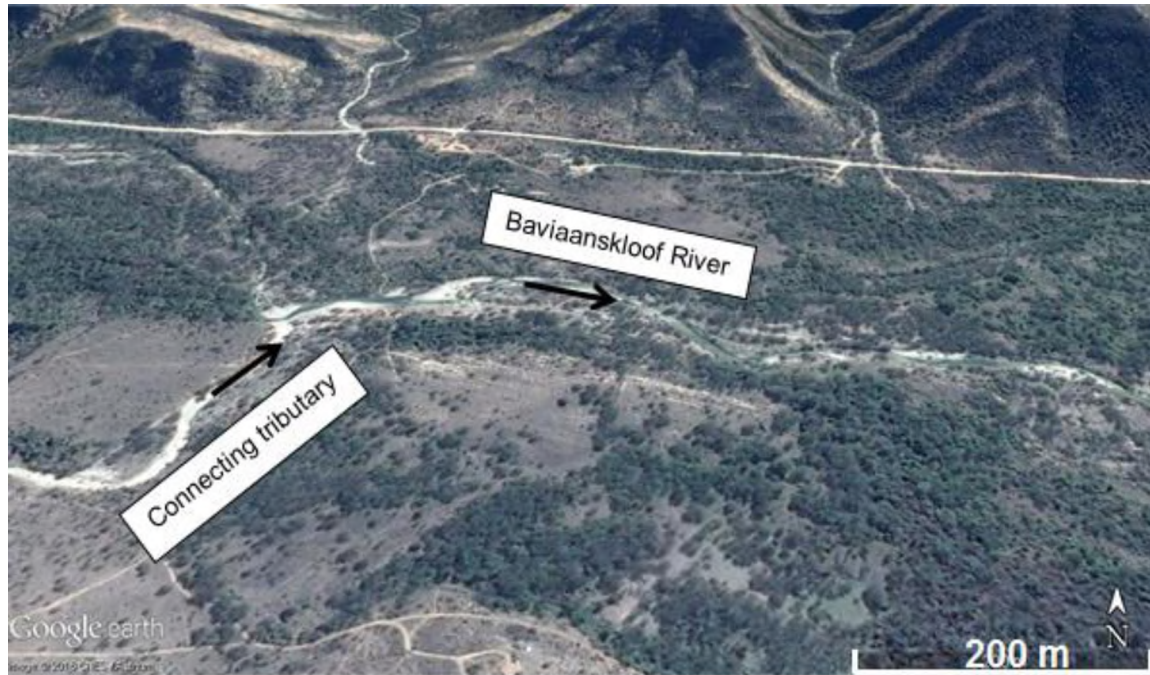
**Figure 6.5:** Example of a cut-and-fill river style along the middle of the study reach. The arrows indicate direction of flow of the trunk stream and a connecting major tributary.

The cut-and-fill style consists of a wide and relatively deep channel, inset within a wider incised channel boundary with a continuous floodplain (Figure 6.5). The trunk stream has recently cut into intact floodplain swamps, adjusting from a once relatively stable and narrow single-thread to anabranching pattern, with a vertically accreting floodplain, to a wide, braided channel dominated by lateral sediment accretion and relative channel instability. Numerous tributaries join the trunk stream from the north and south side of the river valley, increasing the sensitivity of this style to morphological change. The trunk stream is more gently sloping than the transfer river style, with an average slope of 0.0069 m/m. The terraces indicated in floodplain cross-sectional profiles presented in Chapter 5 suggest historic phases of river-floodplain cutting and filling. These cut-and-fill phases are supported with evidence of relatively coarse (high energy) and fine-grained (low energy) sedimentary units in exposed erosion vertical sections. Although the channel appears to be situated in an unconfined floodplain, the existence of human made earthen levees on either side of the channel, as indicated in Chapter 5 (see Figure 5.2), partially limits the ease with which lateral adjustments may occur. During small to moderate floods stream flows are thus confined to the active channel zone. Floodplain accretion for this river style is limited by both a deepened channel and channelizing levees. Coarse sediment is stored mostly along

the active channel zone in lateral and mid-channel bars and on the channel bed in riffles and sediment zones, while fine sediments appear to be transmitted downstream. This river style is the most unstable and sensitive of the three styles identified for the study reach, and has a relatively high frequency of connecting tributary streams of large catchment size.

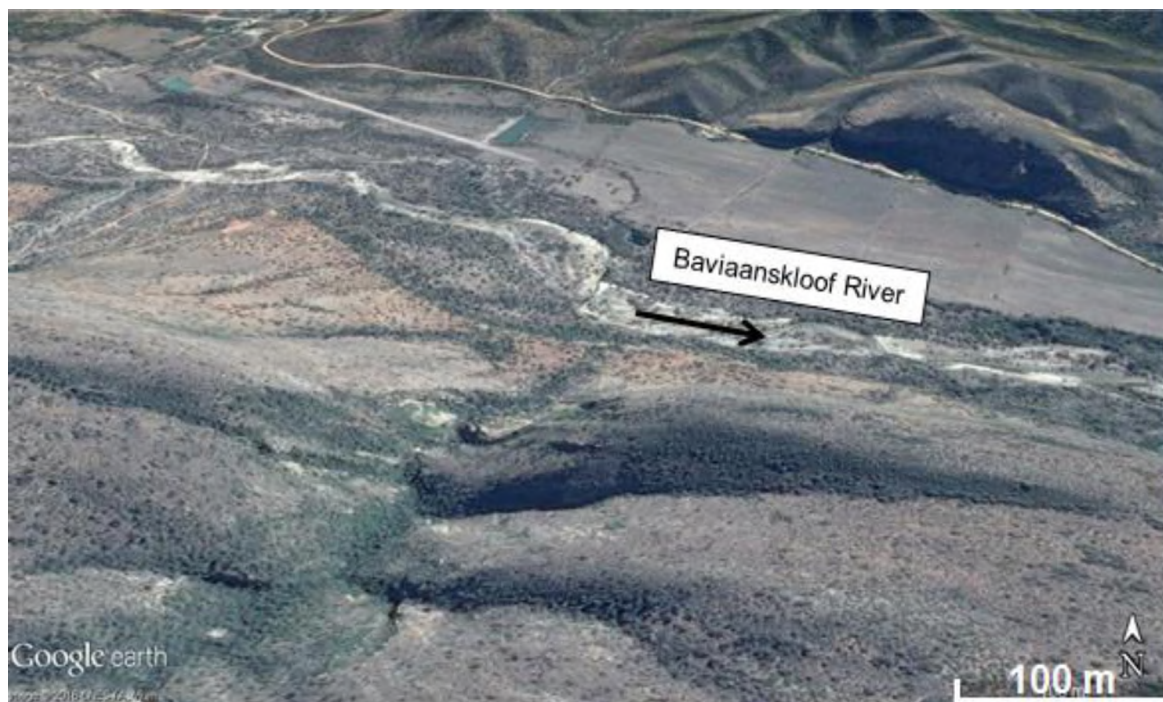
**Figure 6.6:** An example of a floodplain accumulation style along the lower-end of the study reach. Flow direction is indicated by the arrow.

In this style the channel is braided and laterally dynamic and lies within a largely unconfined floodplain setting (Figure 6.6). Earthen levees have limited the lateral connectivity of the channel in some places. However, the presence of lateral channel bars, levees and abandoned channels on the floodplain indicate that the channel is dynamic, storing sediments largely through lateral accretion processes as the channel migrates and avulses across the valley floor. The floodplain is more frequently flooded than the cut-and-fill style due to lower levels of channel degradation and less intensive human channelization. The trunk stream has the lowest average slope, of 0.006 m/m. This style has a lower frequency of connecting tributary streams than the upstream cut-and-fill and transfer river styles. The floodplain accumulation river is an important river zone for receiving and storing some of the sediments that have eroded from the upstream cut-and-fill style.

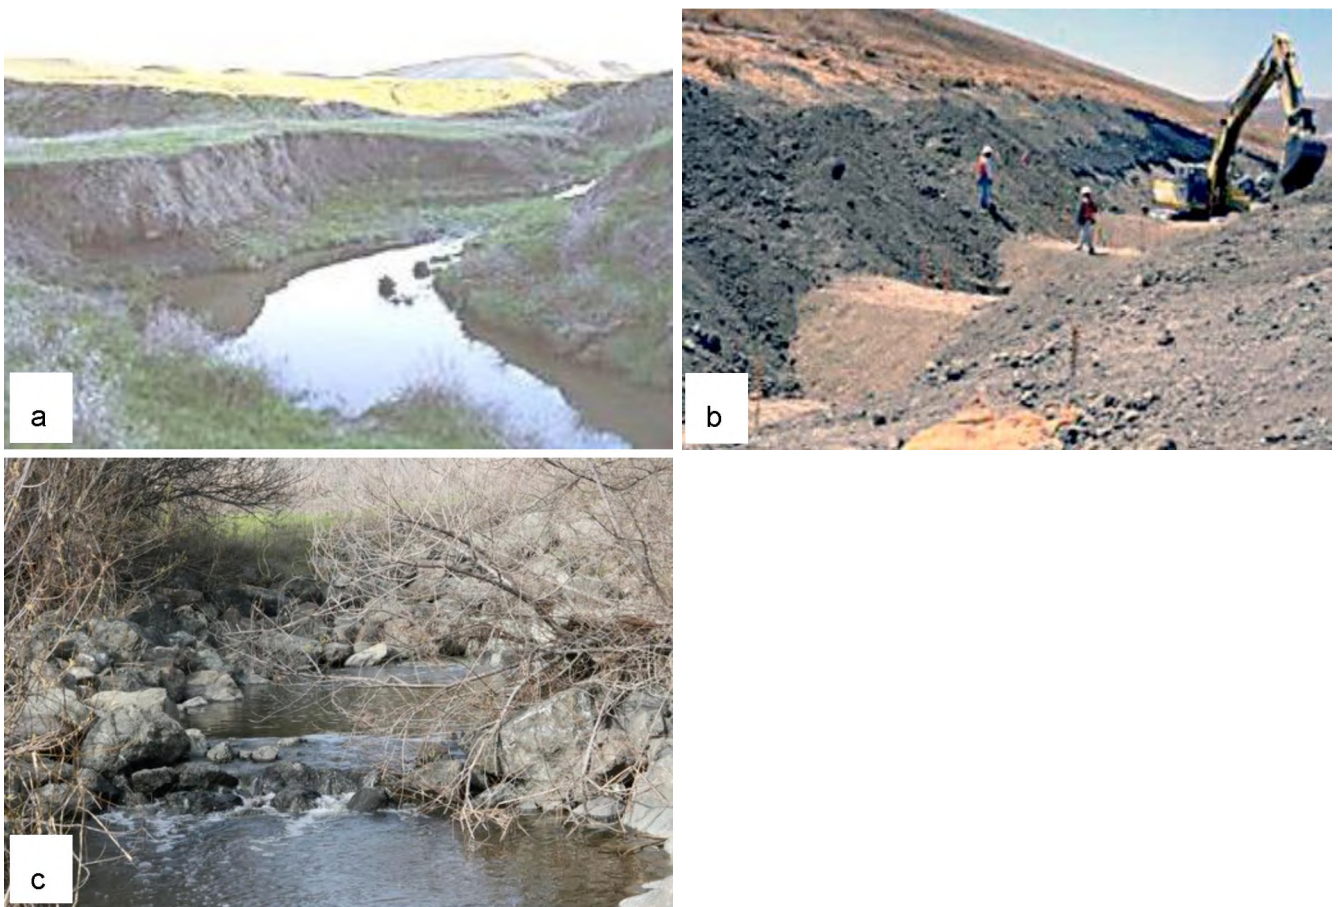
**Plate 7.1:** Rehabilitation of an incised channel reach (a), along East Alamo Creek in California. The re-shaped channel and floodplain and creation of artificial step-pool features are indicated (b), and the rehabilitated, relatively stable channel (c); (Photos by Jeff Haltiner).

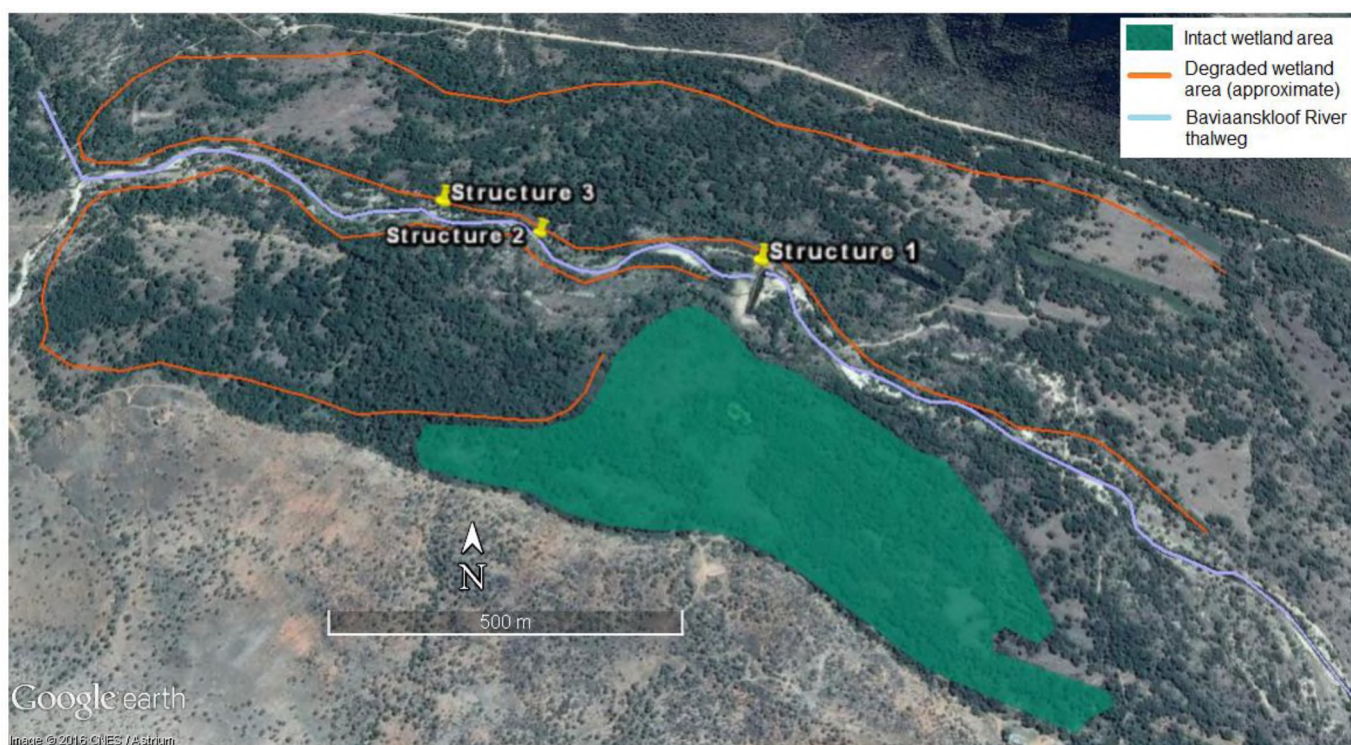
**Figure 7.5:** An aerial view of the location of the proposed gabion weir structures in relation to degraded and intact floodplain wetland for the proposed rehabilitation reach. Structure 1 which was built between 2014 and 2016 is visible in the google earth image, dated 2016.

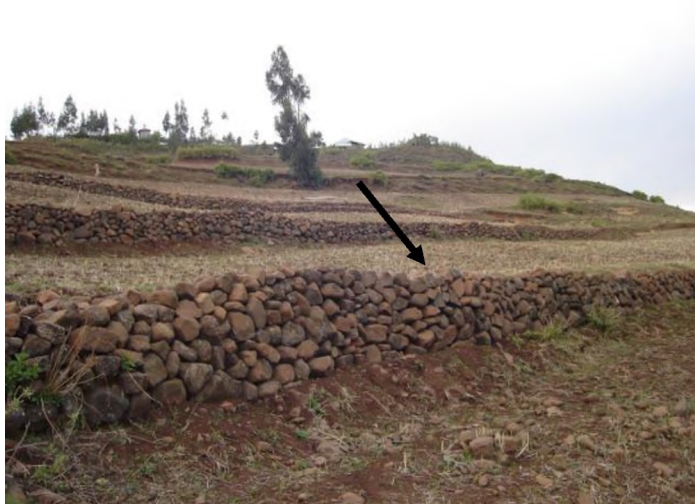
**Plate 7.2:** Stone bunds used to reduce runoff and erosion on hillslopes in agricultural landscapes. The arrow indicates direction of hillslope runoff (Farming First 2012).

(‘Ponding’, Table 7.2), stone or earthen bunds (Plate 7.2 and 7.3), and packing ponded areas with thorn tree branches. The ponding interventions have already been trialed by WfWet in the Baviaanskloof and have proven to be successful in trapping water and sediment and increasing the survivorship of planted *P. Afra* stems.

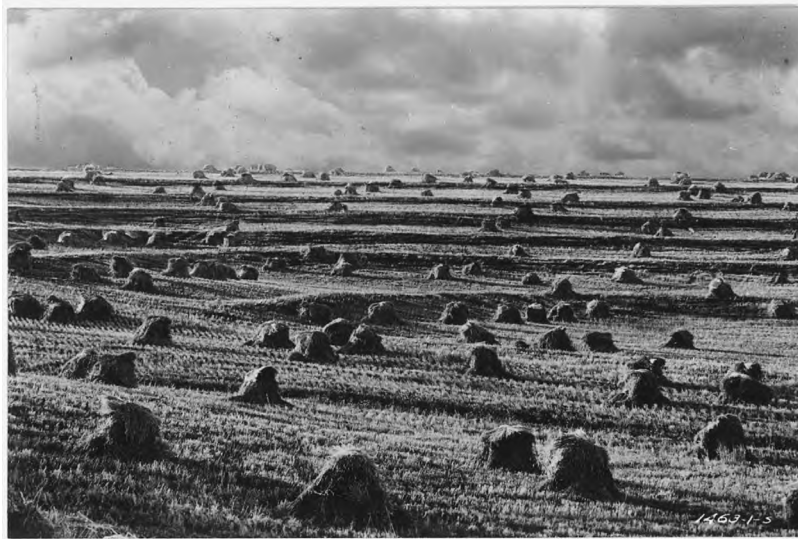
**Plate 7.3:** Earthen terraces used to reduce runoff and erosion in the upper-Mississippi catchment in the 1930s (Wikipedia 2016).
