**A preliminary assessment linking altered catchment
land-cover to the health of four temporarily
open/closed South African estuaries**

A thesis submitted in fulfilment of the
requirements for a degree of

VINCENT ANTONY MASEFIELD

February 2014

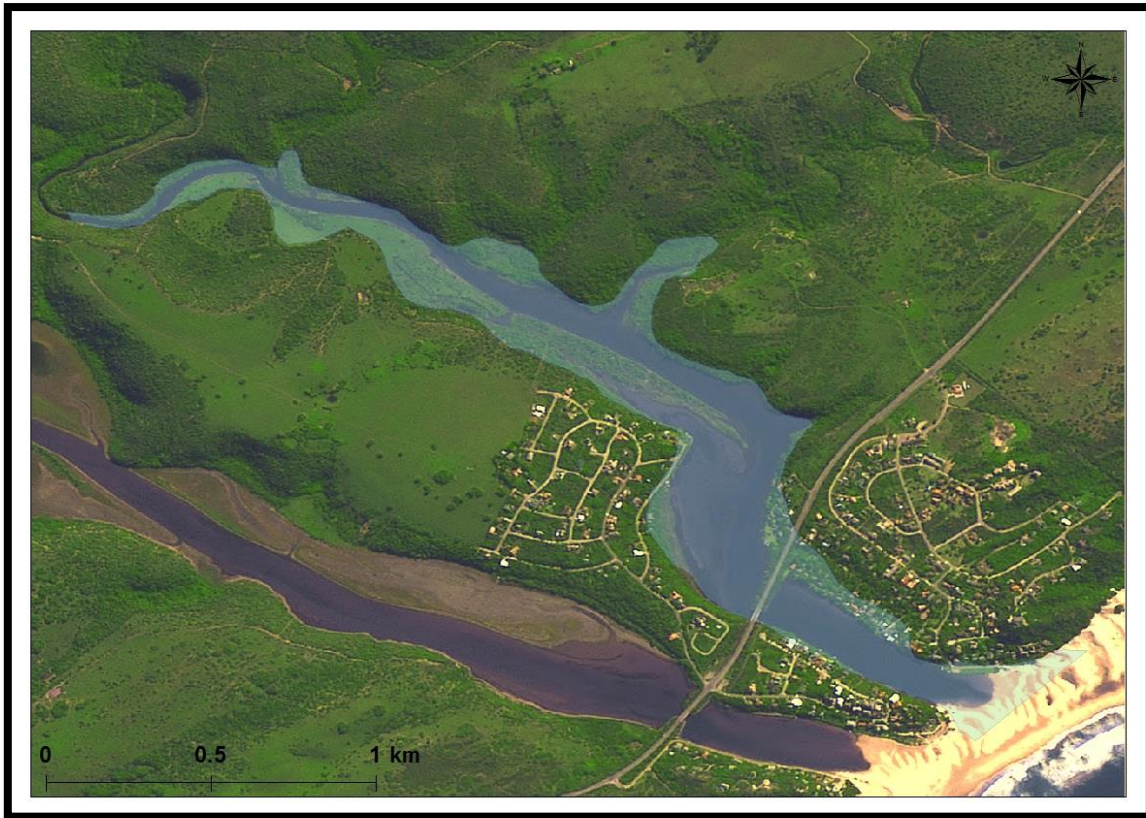
Figure 3.2: East Kleinemonde Estuary with overlaid estuary functional zone delineation. The West Kleinemonde Estuary is in the lower left side of the picture.

The East Kleinemonde Estuary is regarded as a small estuary (Riddin and Adams, 2010: 120; Human and Adams, 2011: 168). At its widest point the estuary is 120 m across and extends 3.5 km from the mouth to the head (Figure 3.2). This system is generally quite shallow with the estuary exhibiting depths ranging between one and two meters in the channel (Human and Adams, 2011: 168).

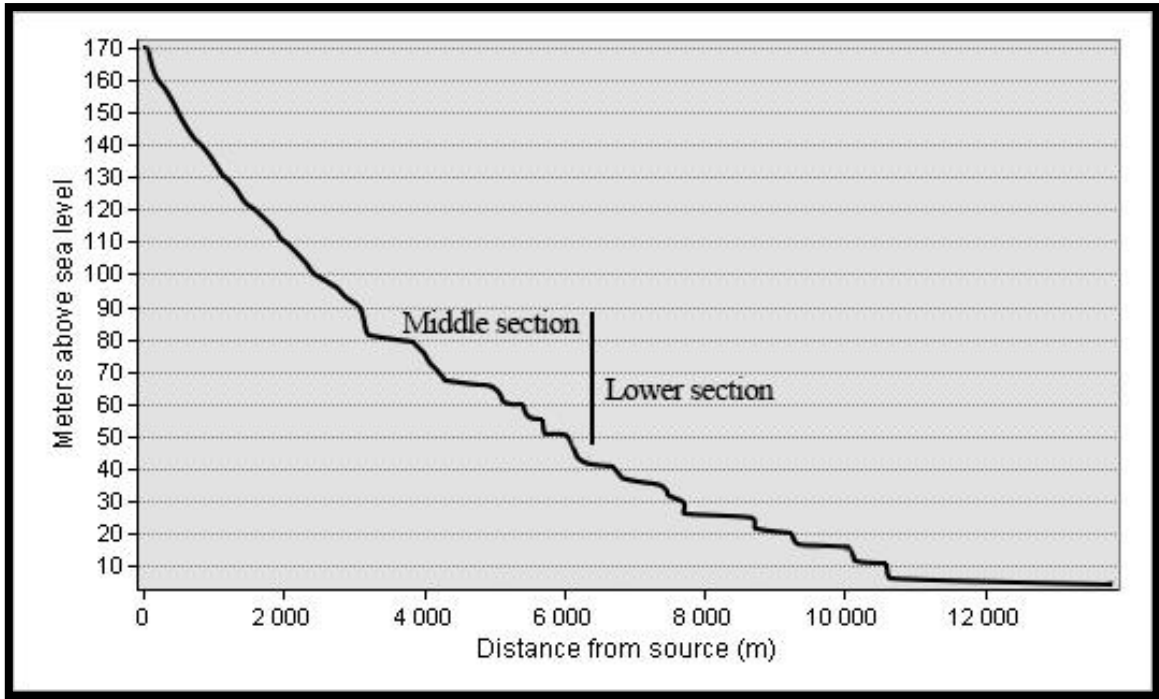
Figure 3.7: Longitudinal profile of the East Kleinemonde River.

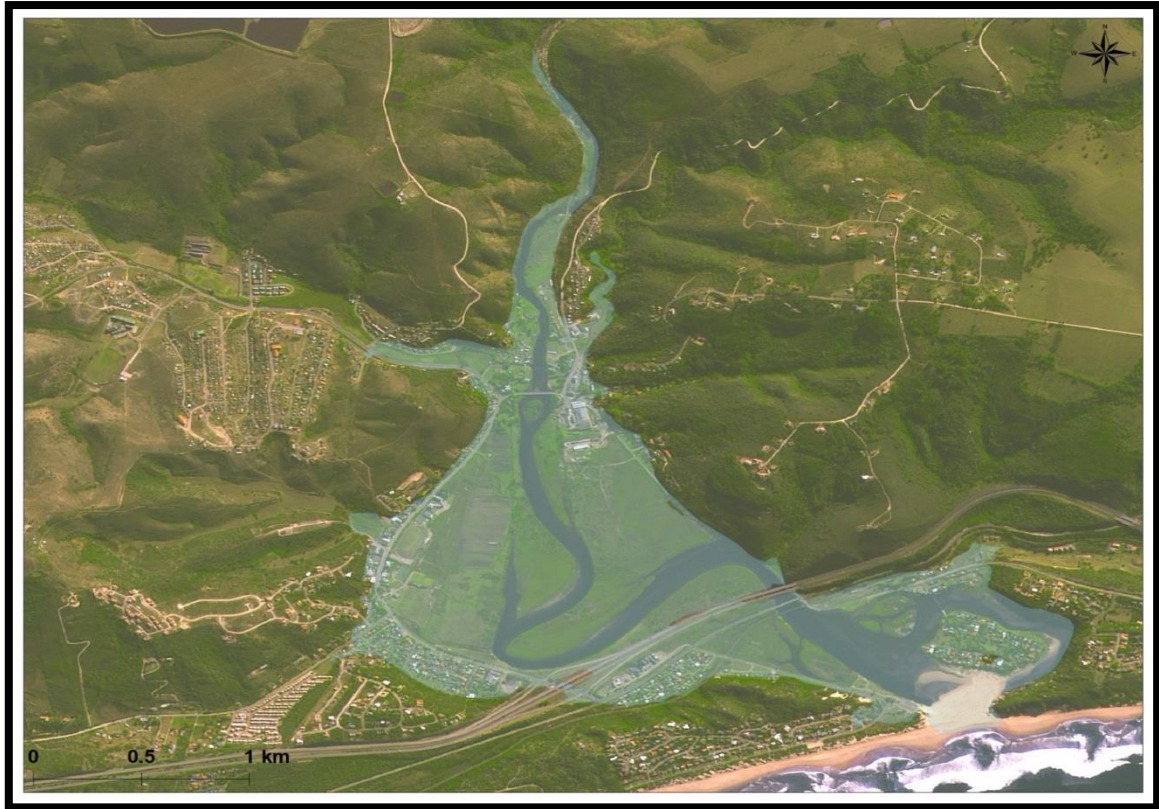
Figure 4.2: Groot Brak Estuary with overlaid estuary functional zone delineation.

The Groot Brak Estuary has been classified as a TOCE, characterised by a sand berm at the mouth which periodically blocks salt water exchange with the ocean. The estuary mouth exhibits a low rocky headland on the eastern side and a sand-spit on the western side (Figure 4.2) (van Niekerk *et al.*, 2009: 5).

Urbanisation is present within the estuary delineation and along portions of its peripheries (Figure 4.2). A noteworthy area of urbanisation exists on a permanent island in close proximity to the estuary mouth. The island is approximately 0.45 km by 0.25 km and is a permanently settled residential area (van Niekerk *et al.*, 2009: 5). In addition urban development is also present within the south-western border as well as the top end of the delineated estuarine functional zone.

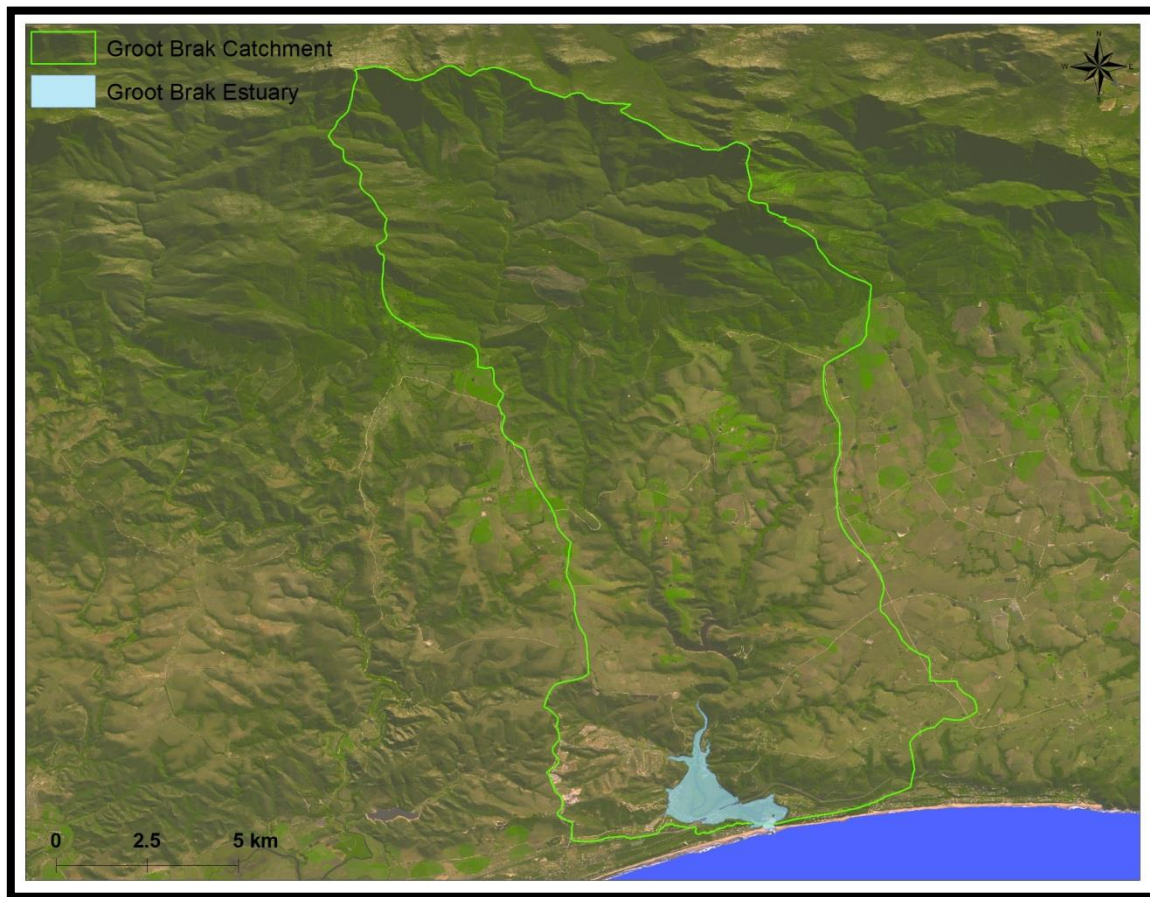
Figure 4.3: Groot Brak Estuary functional zone and catchment boundary delineations.

The Groot Brak catchment (Figure 4.3) is approximately 165 km². Rainfall within the catchment has low variability throughout the year, with the exception of slight peaks during spring and autumn (van Niekerk *et al.*, 2009: 5). The catchment is occasionally subjected to

Agriculture and afforestation are practised within the catchment. Afforestation is primarily localised to the top third of the catchment and agriculture dispersed within the bottom two thirds (Figure 4.3). Types of agriculture practised include: pasture, wheat and vegetable cultivation (Anchor Environmental, 2012: 11). Afforestation, coupled with water abstractions

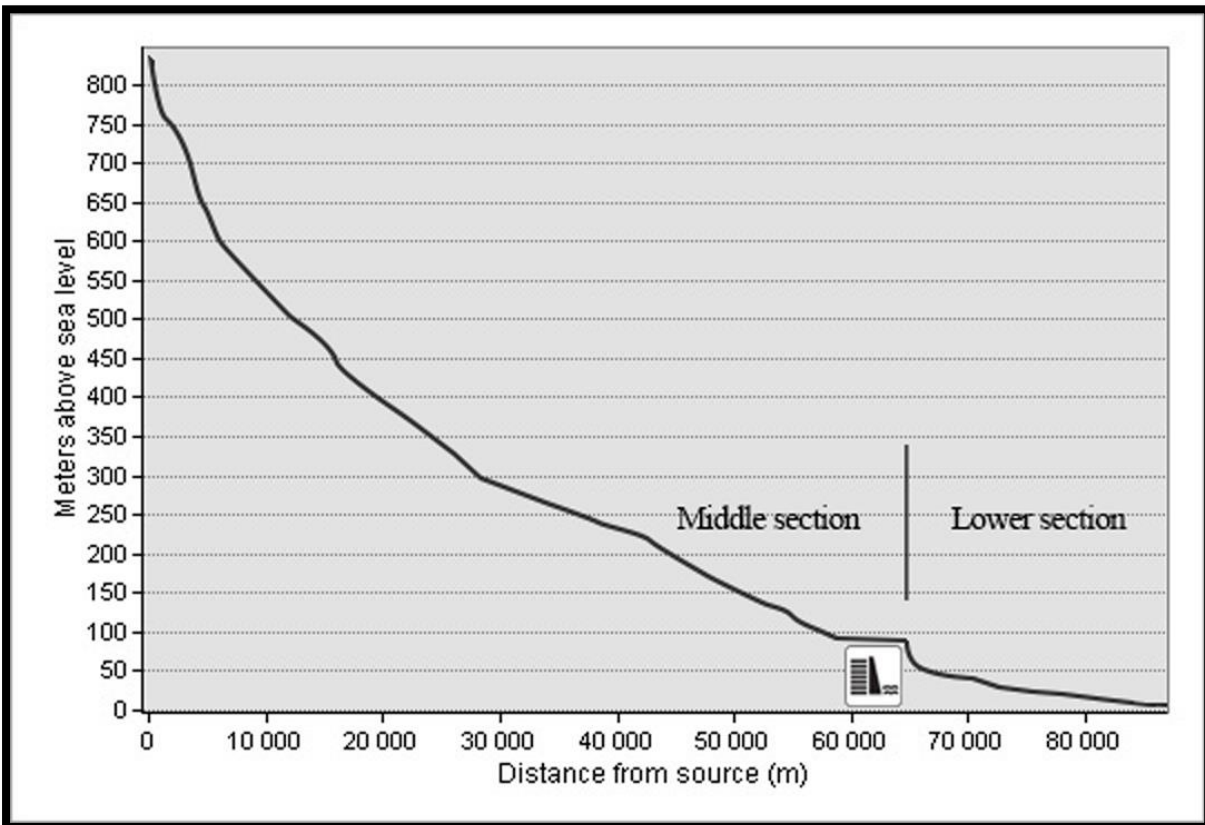
The profile indicates that there is a major change in gradient at 100 m (i.e. approximately 65 km from the river source). At this point the major change in river gradient is due to the presence of the Hazelmere Dam. The lower section of the catchment has therefore been classified as all areas of the catchment which do not exceed 100 m.

Figure 5.7: Longitudinal profile of the Mdloti River.

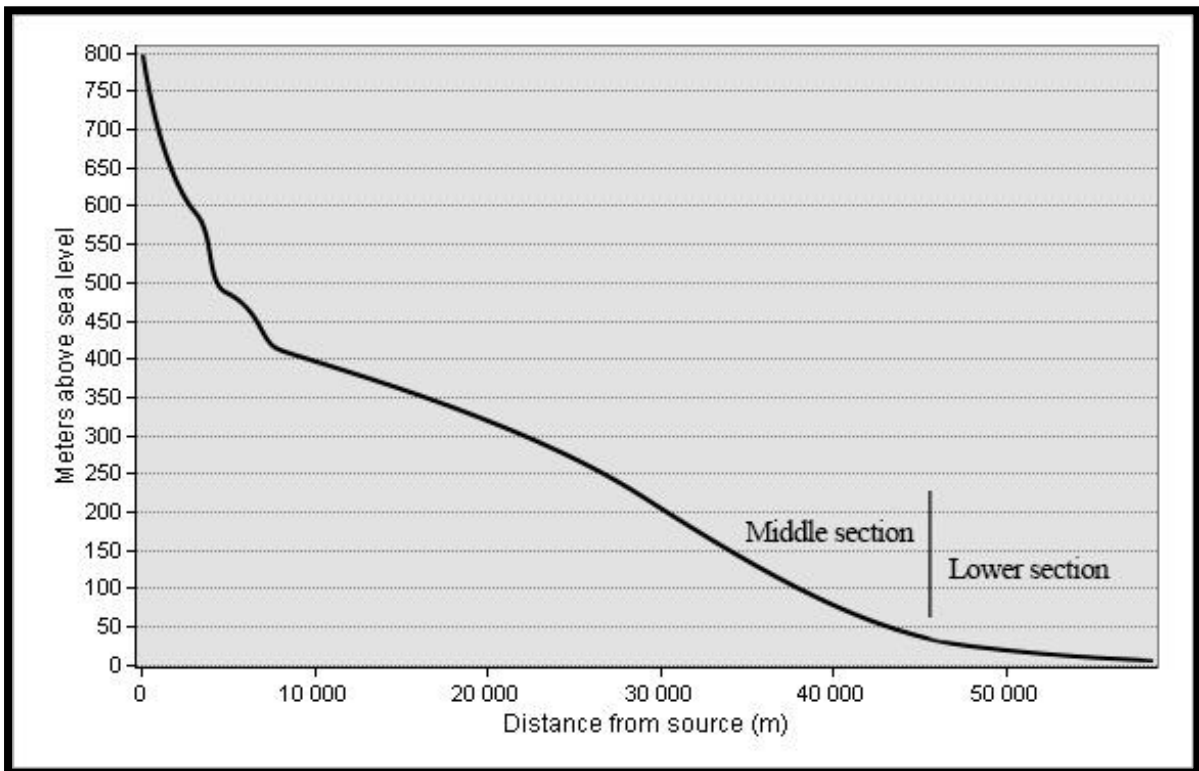
Without any major changes in river morphology closer to the estuary, it was difficult to distinguish the exact point of change from the middle to lower section. The gradient of the river starts to flatten approximately 45 km from the river source at 40 m, and for the purpose of this assessment all land below this altitude will be classified as part of the lower section.

Figure 6.7: Longitudinal profile of the Tongati River.
