**THE GEOMORPHOLOGICAL IMPACTS OF  
IMPOUNDMENTS, WITH PARTICULAR REFERENCE TO  
TRIBUTARY BAR DEVELOPMENT ON THE KEISKAMMA  
RIVER, EASTERN CAPE.**

*THESIS SUBMITTED  
IN FULFILMENT OF THE REQUIREMENTS  
FOR THE DEGREE OF MASTER OF SCIENCE OF RHODES UNIVERSITY*

Gillian Kathleen M<sup>c</sup>Gregor

February 1999

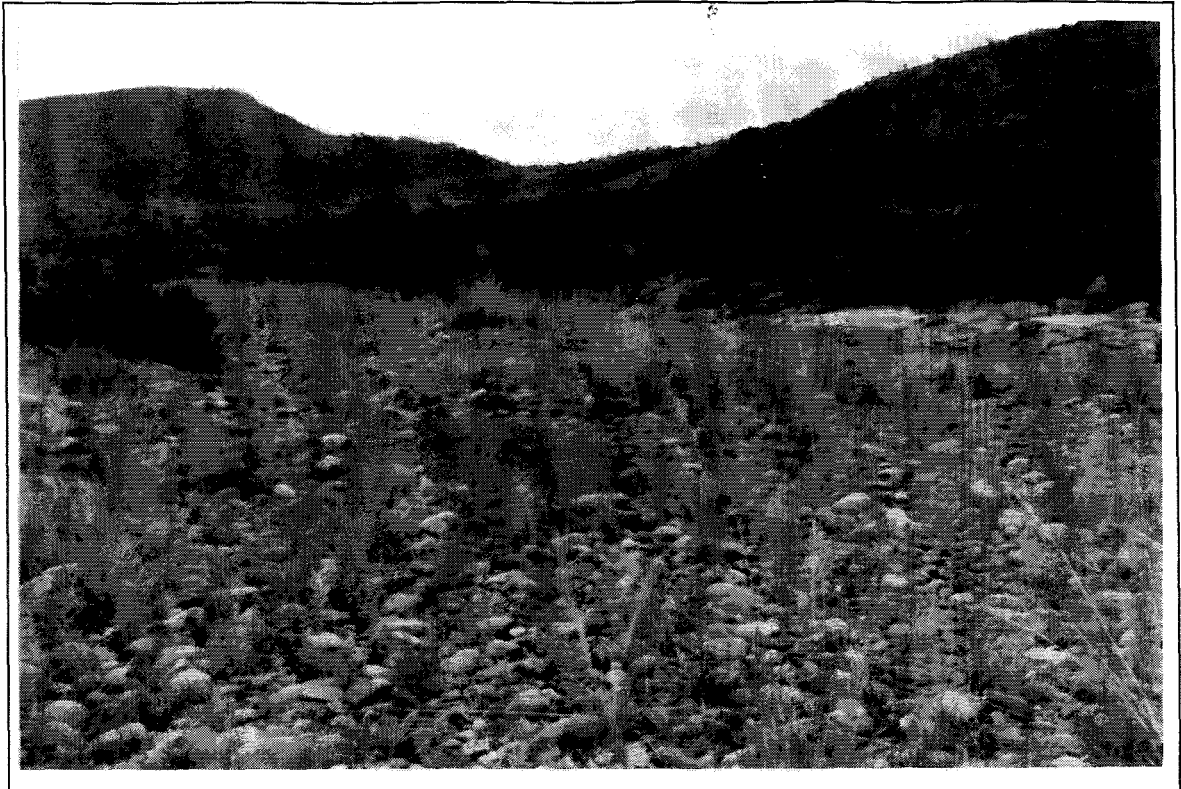
*Plate 3.3:* Bivane IFR site 2 showing cobble terrace with vegetation growth.

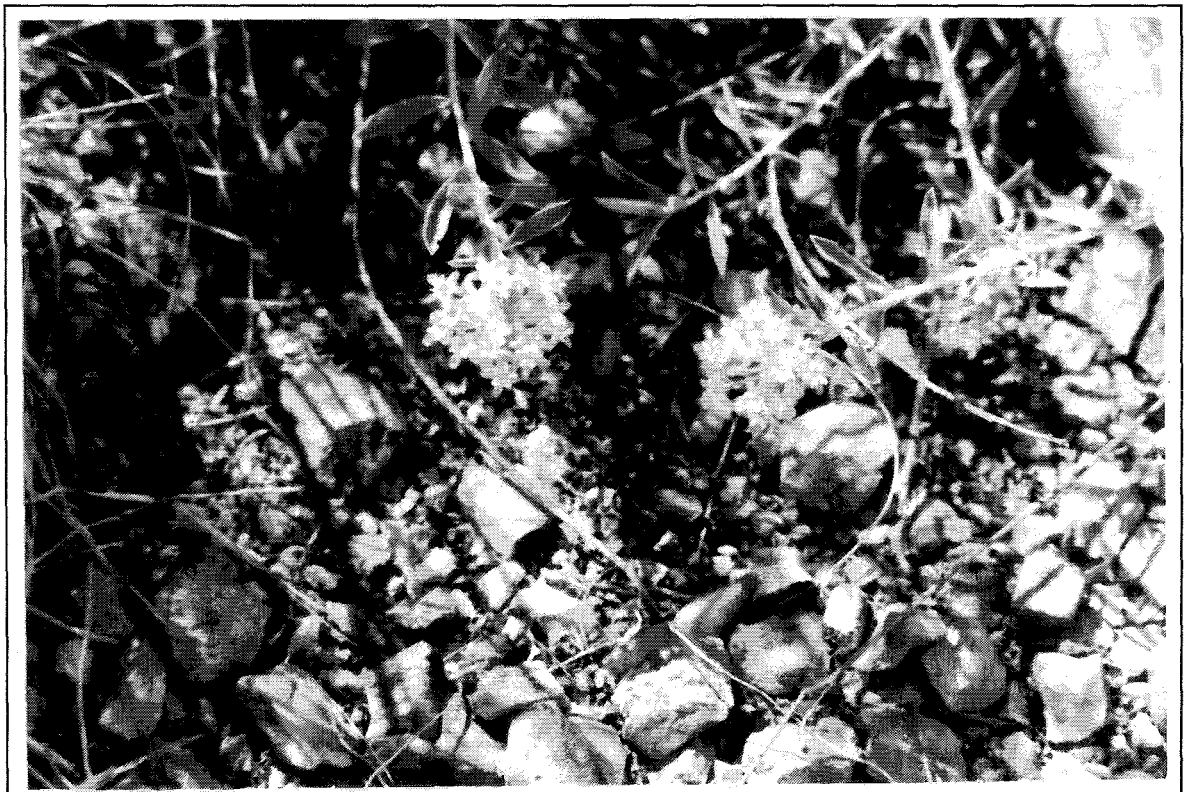
*Plate 3.4:* Bivane IFR site 2, upstream view - gravel deposit at tributary mouth.

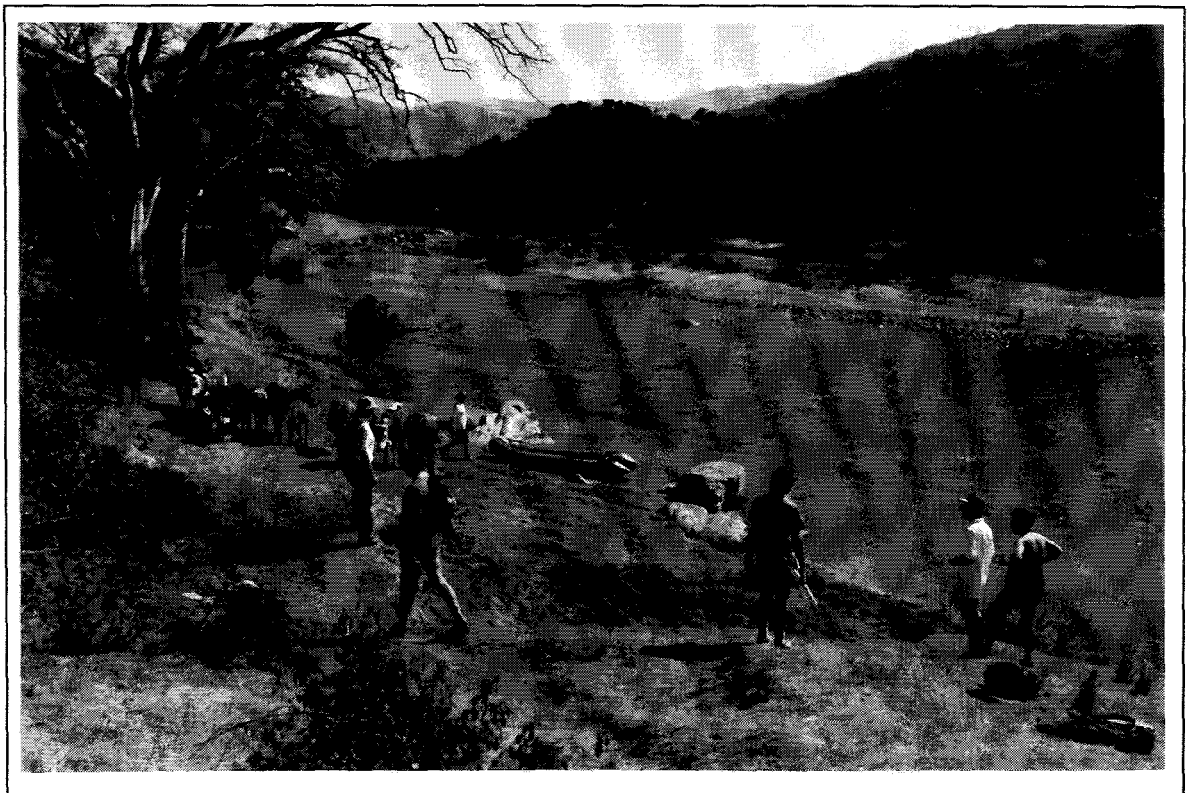
Plate 3.5: Komati IFR site 1, showing run feature with cobble bar and island in the background.

*IFR Site 1* (Plate 3.5) is about 15km downstream of the dam wall. The reach is characterized by a confined channel with a gradient of 0,008 and pool- rapid sequences. The unregulated mean annual flow amounts to 24% of the regulated volume, and the unregulated area equals 12% of the regulated catchment. The surrounding catchment, vegetated mostly by natural vegetation is in good condition. A settlement and cultivated lands, as well as trampling on the river banks by livestock would provide localized sediment input. The site is used as a crossing point for people and livestock, with associated disturbance. The gradient of the stream in this reach is sufficient that most of the incoming fine sediment is flushed further downstream. Upstream of the site is a long pool, with a well defined right bank terrace, edged with reeds. At the lower end, where the channel gradient changes, a small side stream (Plate 3.6) divides off towards the left bank around a large, well vegetated cobble and sand island. The side channel is two to three metres wide, with

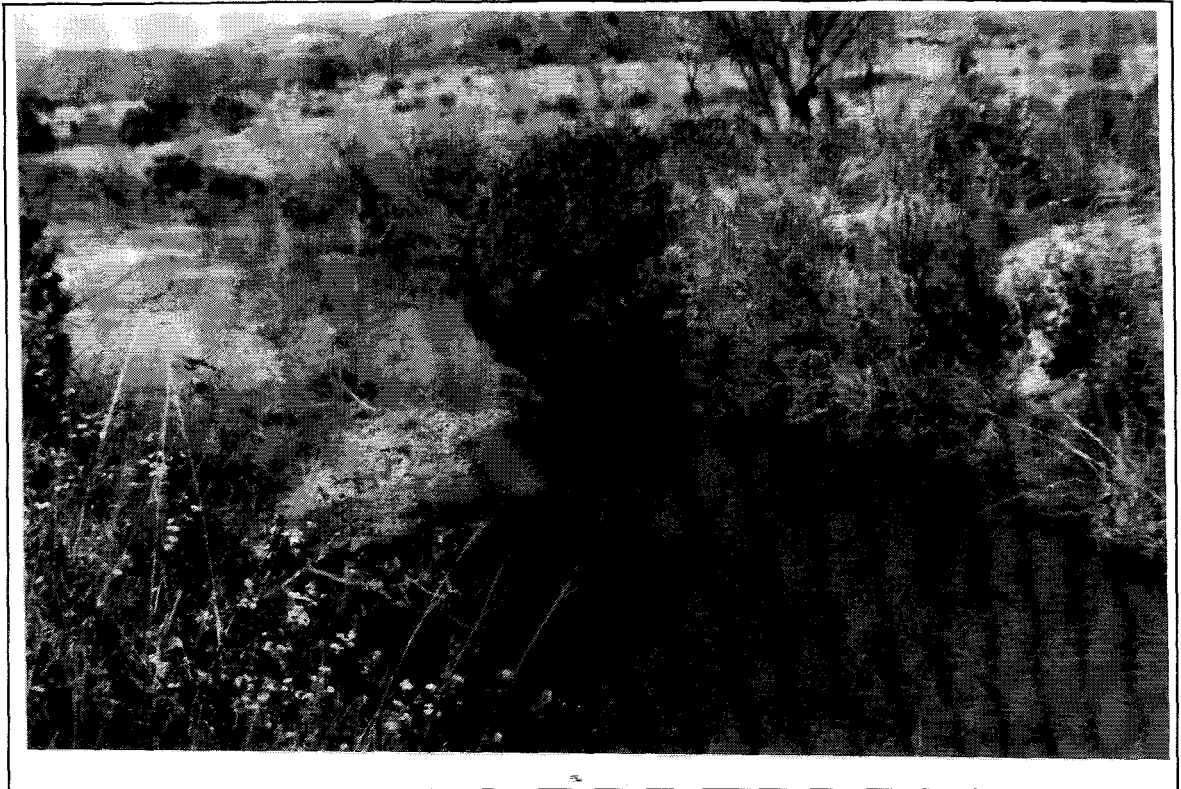
*Plate 3.6: Komati IFR site 1 - secondary channel.*

On the right bank there is a well grassed secondary channel, which leads off the main channel, across the narrow right bank terrace. It intercepts an ephemeral tributary, which crosses the terrace at right angles. The left bank has a terrace, 40-50m wide, which is well vegetated and has been burnt recently. The banks leading up from the terrace are steep.

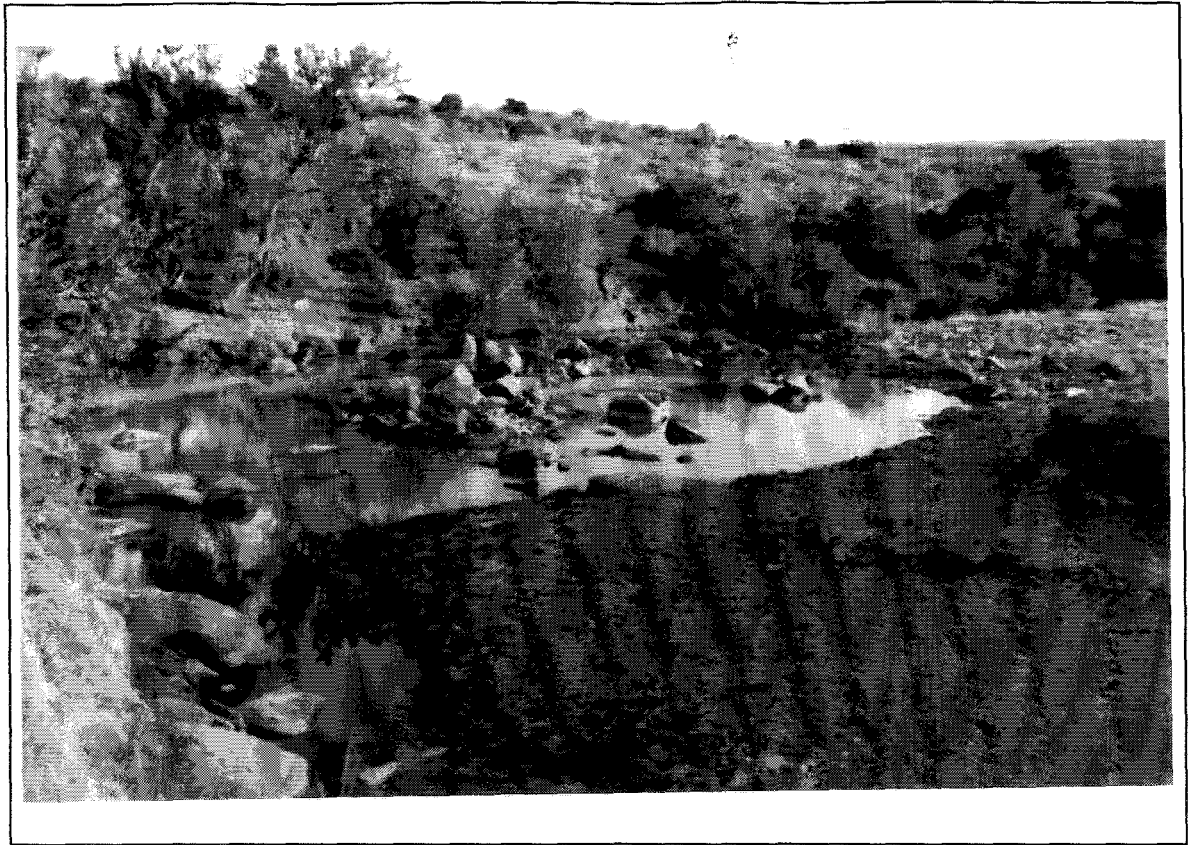
*Plate 4.10:* Keiskamma/Regu junction.

*Regu* (Plate 4.10): the main catchment area is gently sloping, sparsely covered grassland, with cultivated lands and several settlements. The channel is incised, and controlled by a series of rock outcrops in the last 3 km, where it flows through a predominantly bedrock channel of waterfalls and small pools. There is a substantial cobble and boulder bar at the junction, certainly a permanent feature.

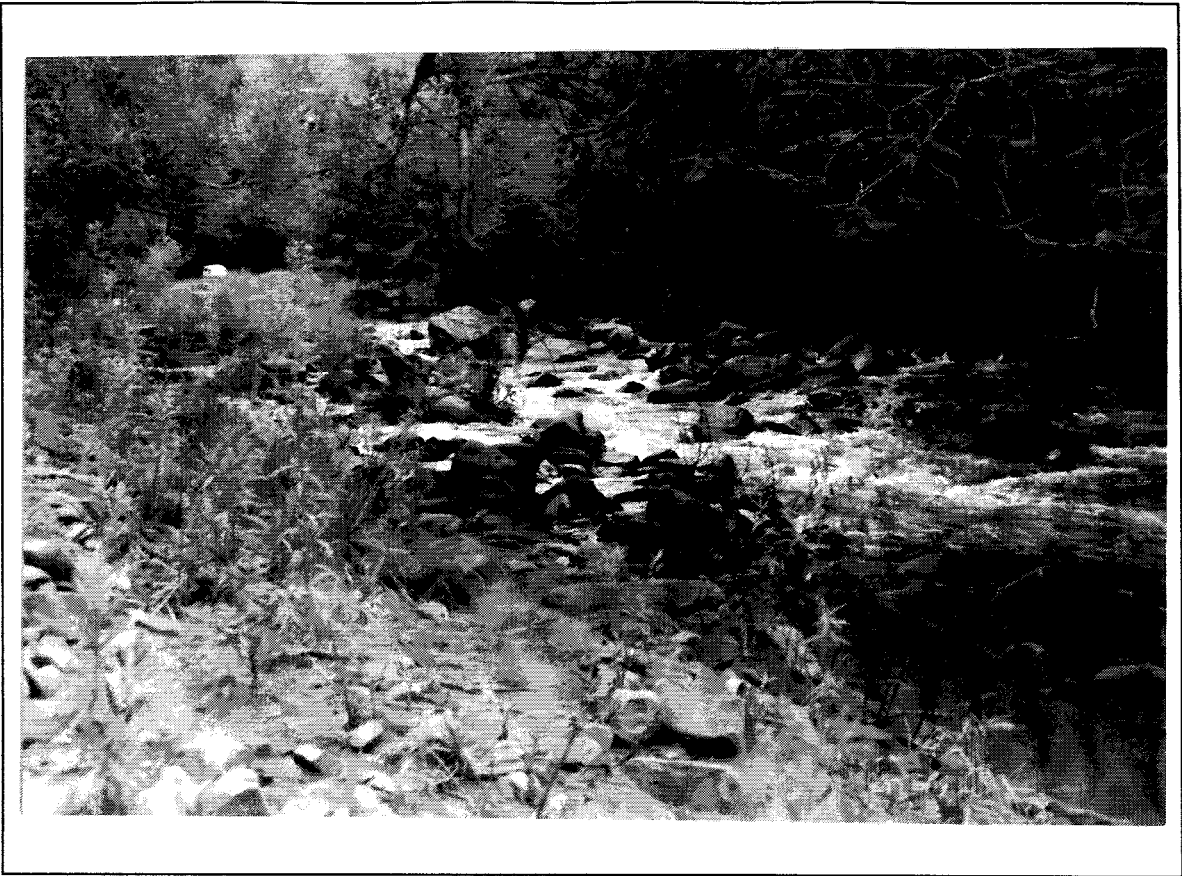
*Plate 4.13:* The Amatola River in its lower reaches.

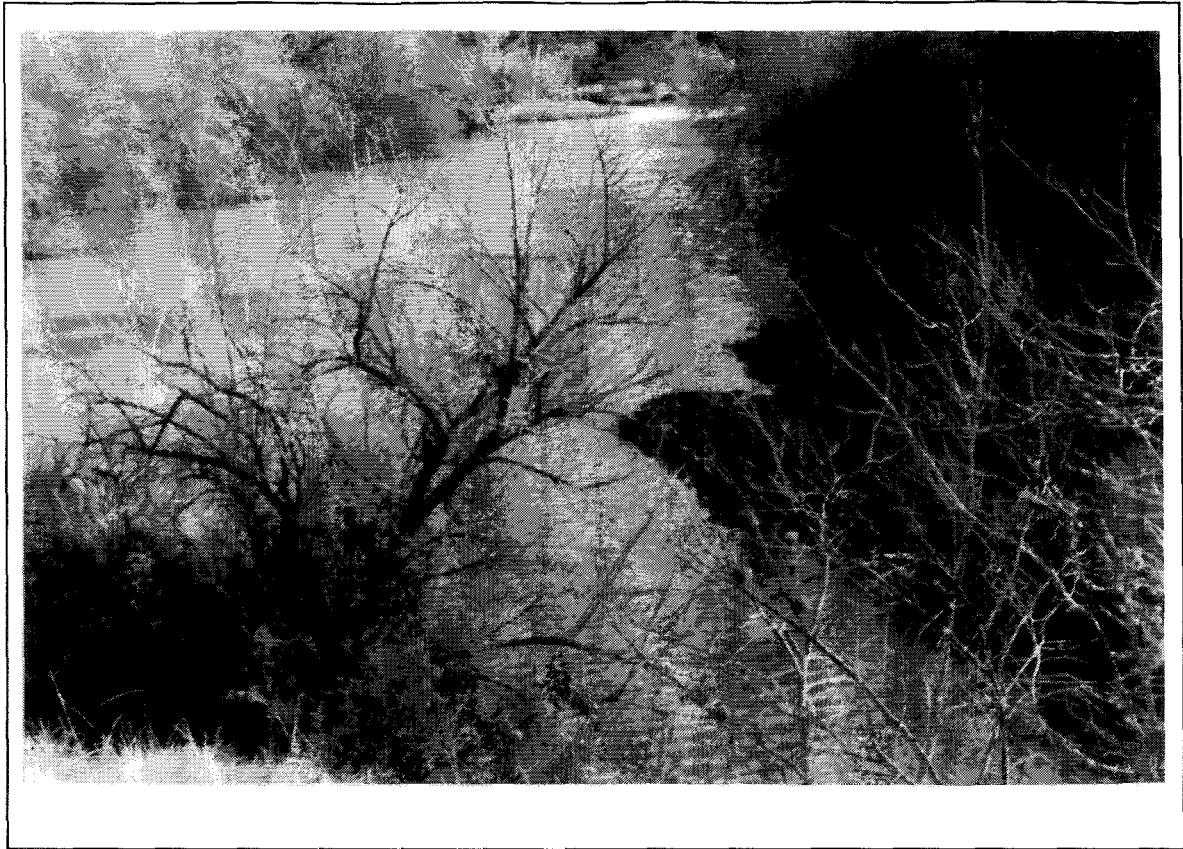
*Plate 4.15:* Keiskamma/Amatola junction - downstream view.

A plan of the site is shown in Figure 4.15. Plates 4.15 and 4.16 show the upstream and downstream views at the site. Cross sections and substrate descriptions taken at, above and below the tributary are shown in Figures 4.16 to 4.19. The Amatola enters on a slight bend in the river - in the middle of a long pool, bounded by moderately stable, well vegetated sheer banks. The upstream cross section is dominated by a bedrock and boulder substrate, with silt

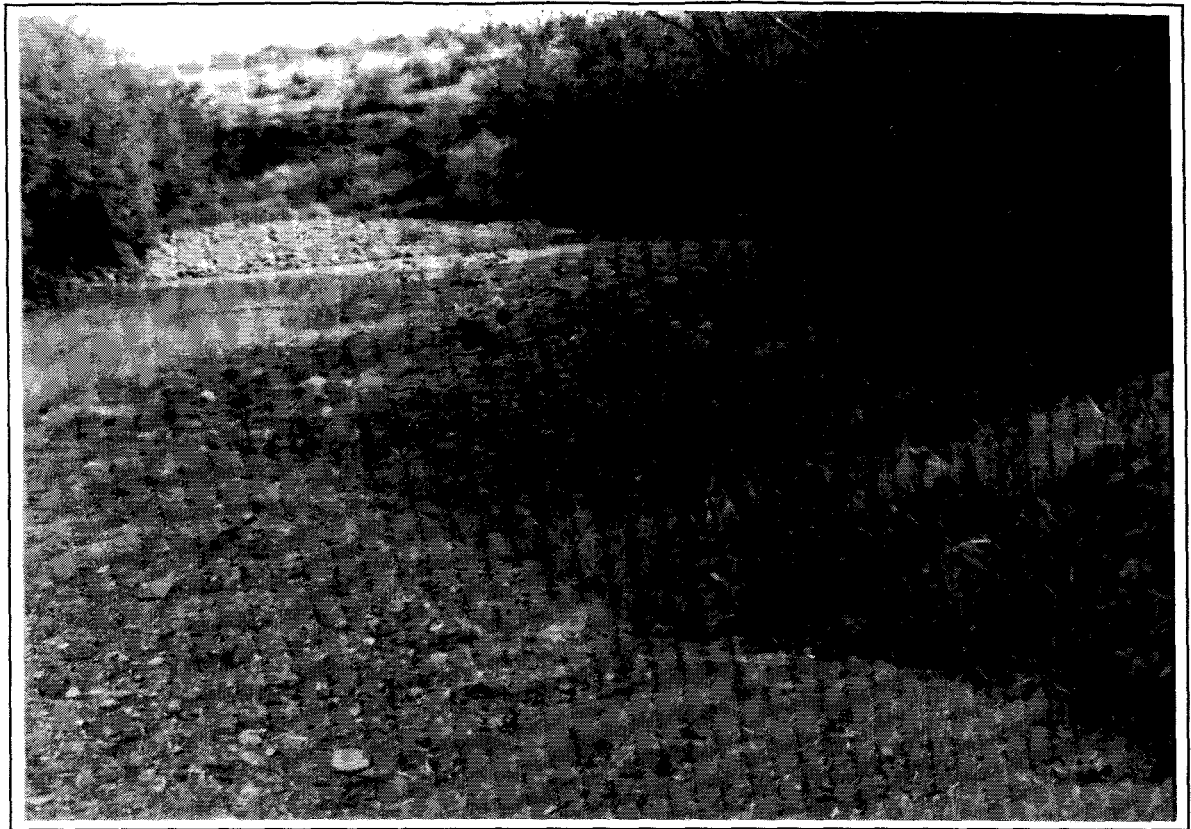
*Plate 4.24:* Keiskamma/Ncqwazi junction, lower end of bar, 1997.

The extensive tributary bar at the intersection with the Keiskamma is the product of the erosion of sediments from the Ncqwazi catchment. Composed mostly of unconsolidated gravel size and smaller sediments (Figure 4.36) the bar is substantial in extent, stretching downstream for some 50m. Field visits at two different dates show how changeable it is as is illustrated in the bar morphology maps done at two dates ( Figure 4.34). Plates 4.22 and 4.23 show the change in the bar from 1996 to 1997, while Plate 4.24 shows the form of the lower end of the bar. The bar maps in Figure 4.34 show that the form of the bar has changed from one year to the next. These are also be related to Rowntree and Dollars (1994) sketches made in 1989 and 1993, which are indicated in the figure. A sizeable section of the left bank had collapsed between 1996 and 1997 which can be seen in Plate 4.23.

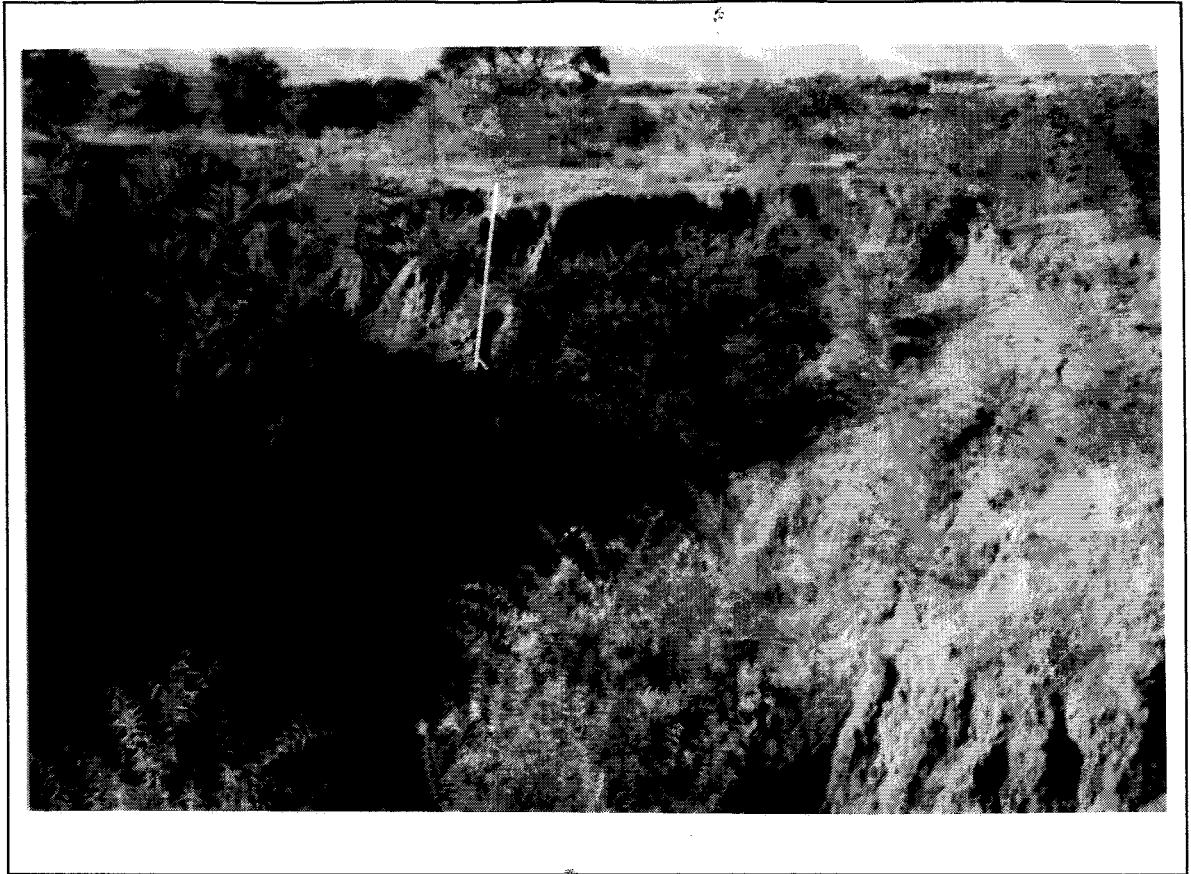
*Plate 4.25:* Gullies leading into the Debe.

A plan of the site is shown in Figure 4.41. Plates 4.27 and 4.28 give a view of the site. The main channel is well defined, with an identifiable bench marking the edge of the low flow channel/wetted perimeter. The long pools are broken by ribs of bedrock, and associated sediment deposits which break the gradient of the river. An assessment of time series aerial photos shows that the catchment has been degraded over the past twenty years. The riparian zone has been degraded by stock grazing, which means that runoff delivers sediment directly to the stream channel.

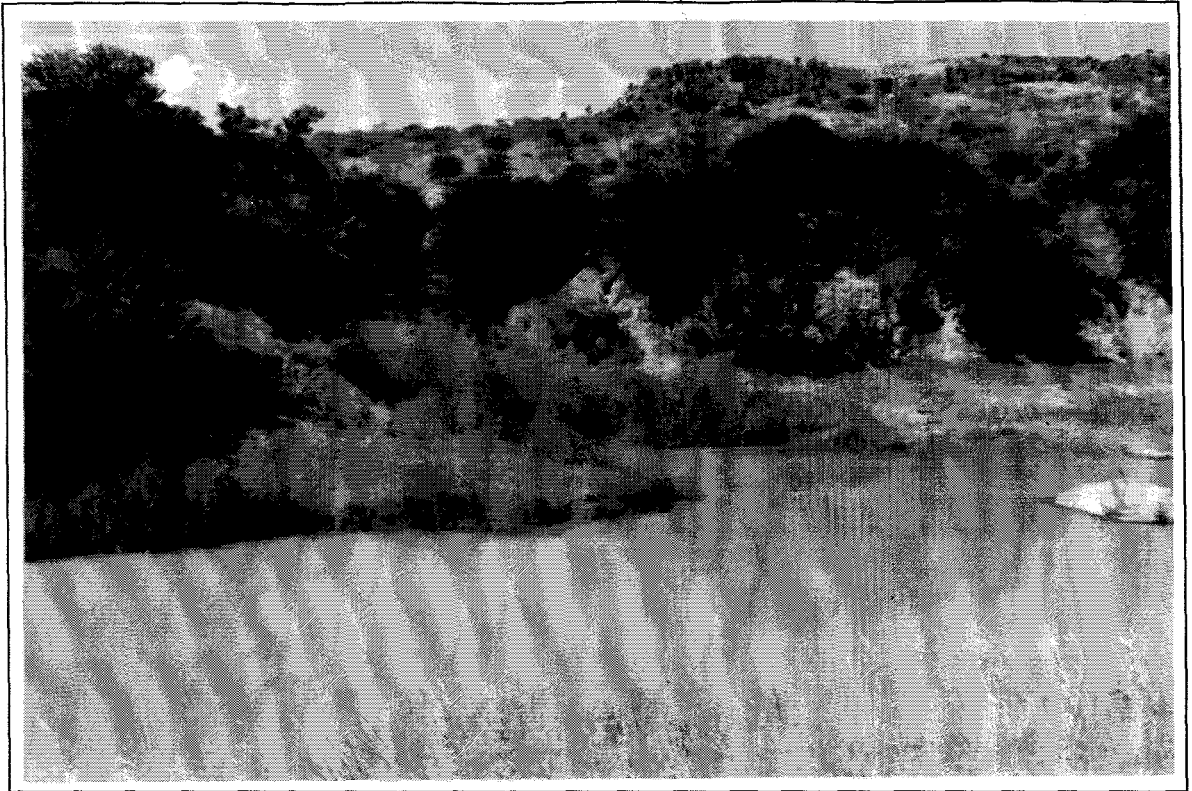
*Plate 4.27:* Keiskamma/Debe junction.
