**AN INVESTIGATION INTO THE NATURE AND EXTENT
OF EROSION AND SEDIMENTATION IN THE
MAQALIKA DAM CATCHMENT, MASERU.**

THESIS

*Submitted in Fulfilment of the
Requirements for the Degree of*
MASTER OF SCIENCE

of Rhodes University

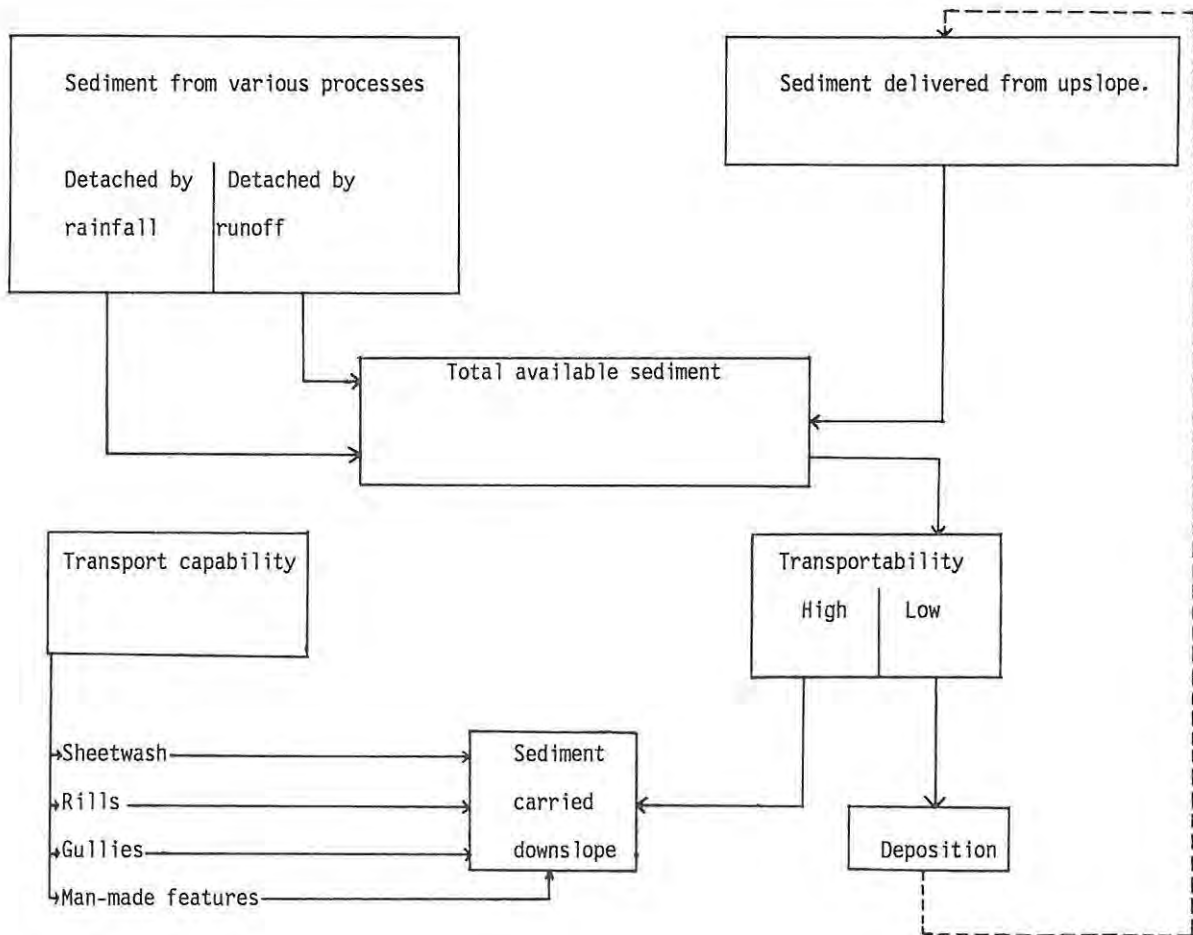
Figure 1 A theoretical model of sediment transport. Adopted and modified from Meyer (1986).

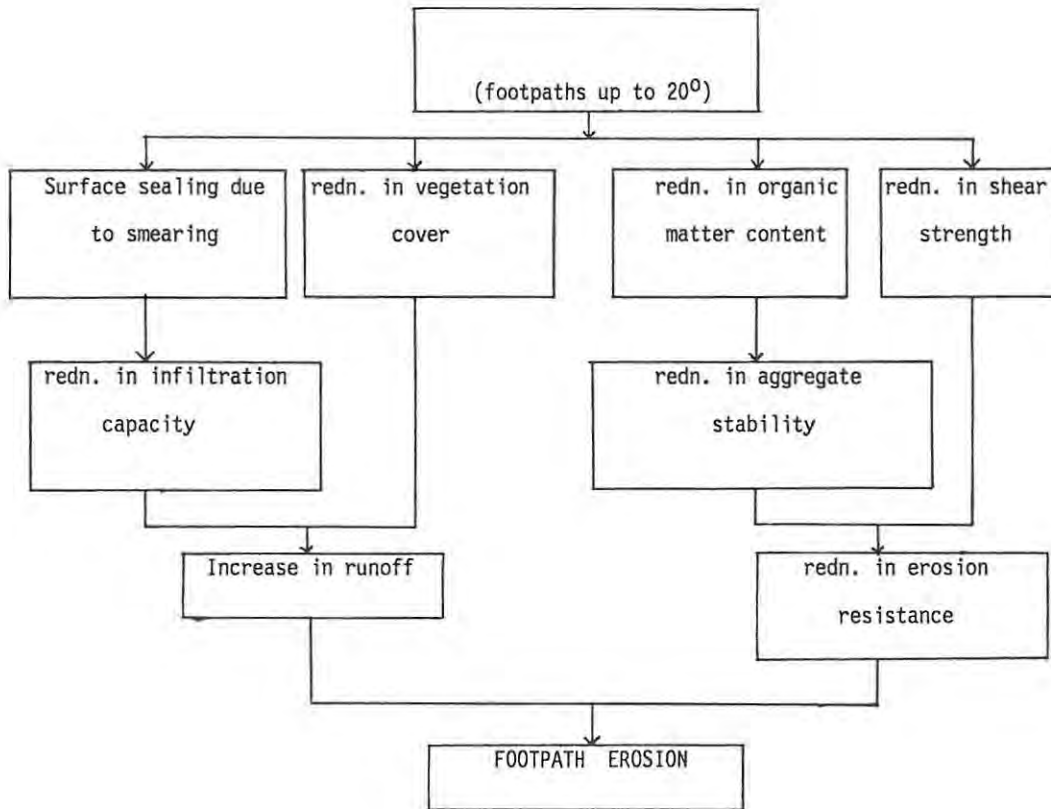
Figure 3 Stages leading to footpath erosion (Garland, 1983).

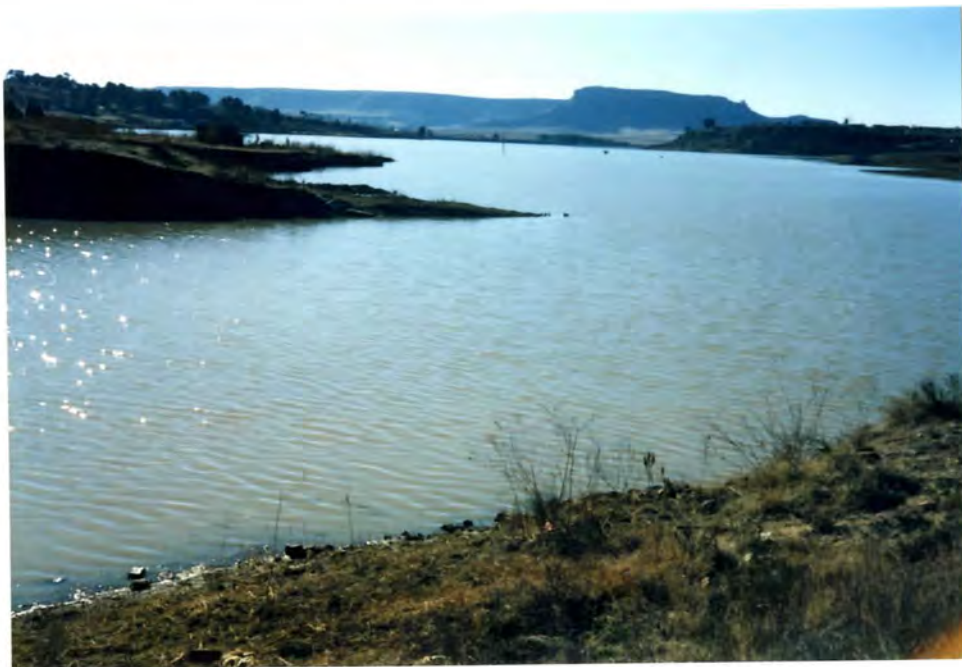
Plate 2 Maqalika reservoir observed from the south.

From the listed features, one can describe the reservoir as being long and narrow, as shown in Plate 2. The reservoir is expected to have a relatively long retention time and a high trap efficiency because it has a large capacity and a relatively low inflow.

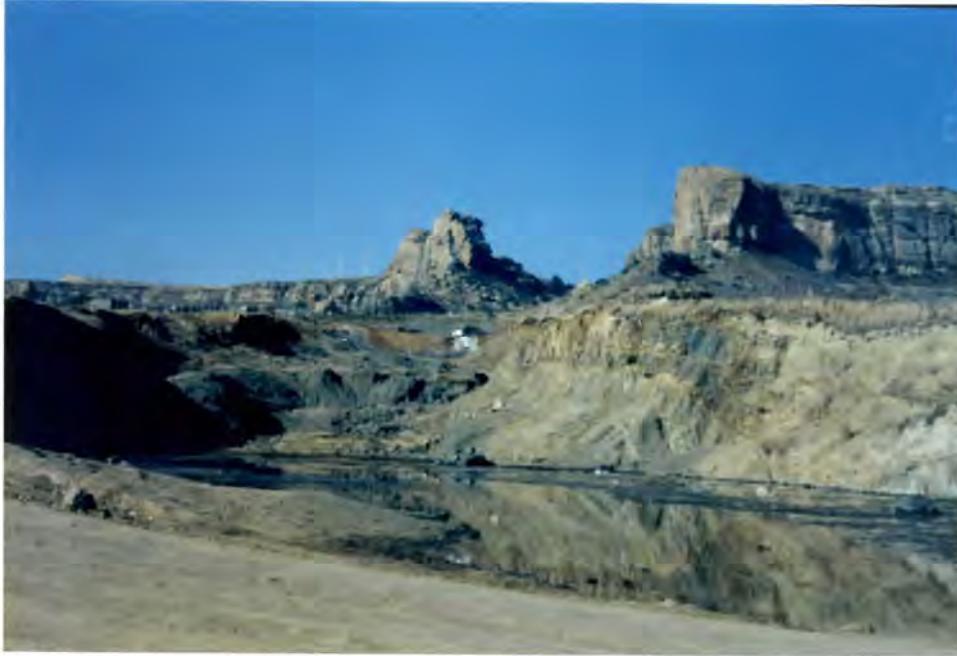
Plate 3 The Lancer's gap dolerite dyke.

Dolerite dykes formed in this region are less resistant to weathering than the surrounding sedimentary rock which comprises cave sandstone (Dangroup, 1980). Dolerite dykes weather much faster than the cave sandstone leaving visible depressions on the surface. These features of contrasted susceptibility to decomposition are developed exclusively in regions where cave sandstone appears at the surface (Meijs, no date). In the study area one can easily trace the depressions or gaps in the yellow cliffs of the sandstone beds. After a period of selective weathering, the relatively resistant sandstone walls stand out as ridges with a gap in between them. An example of this feature is the Lancer's gap dyke which forms a distinct valley in the escarpment bordering the Berea Plateau, shown in Plate 3. Where dolerite dykes occur through Red beds the opposite is observed. The surrounding rocks weather much faster than the dolerite dykes, leaving visible ridges and spurs along the landscape.

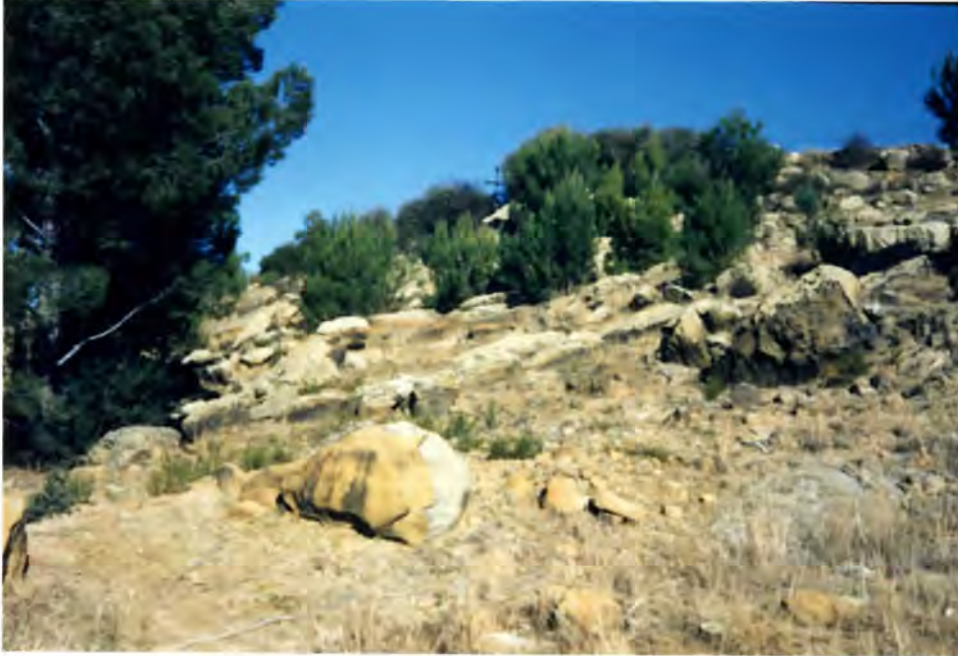
Plate 4 Debris slope with boulders standing out.

Debris slopes are formed below scarps due to accumulated weathering products consisting of pebbles and large boulders derived from the scarp above (Schmitz, 1980). The boulders may be embedded in a sandy matrix or left standing out on the surface, as shown in Plate 4. Some areas of the debris slope are partly covered by colluvium deposits which may be gullied. Schmitz (1984) noted that debris slopes reach a gradient of 34° throughout Lesotho. Due to their steep gradient, debris slopes are exposed to torrential runoff which may have a bearing on downslope erosion.

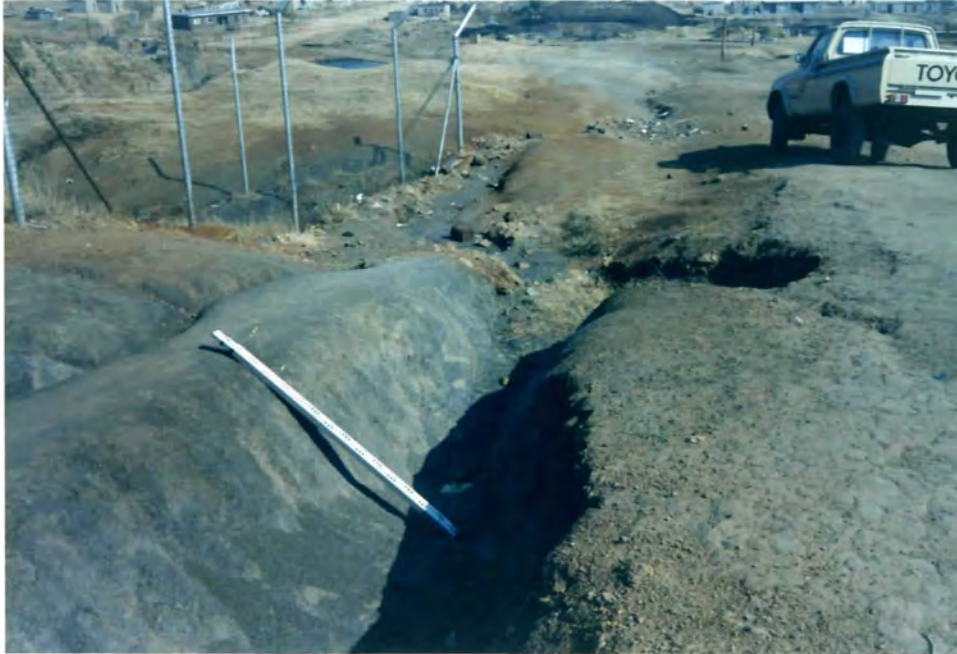
Plate 7 Road drain developing into a gully.

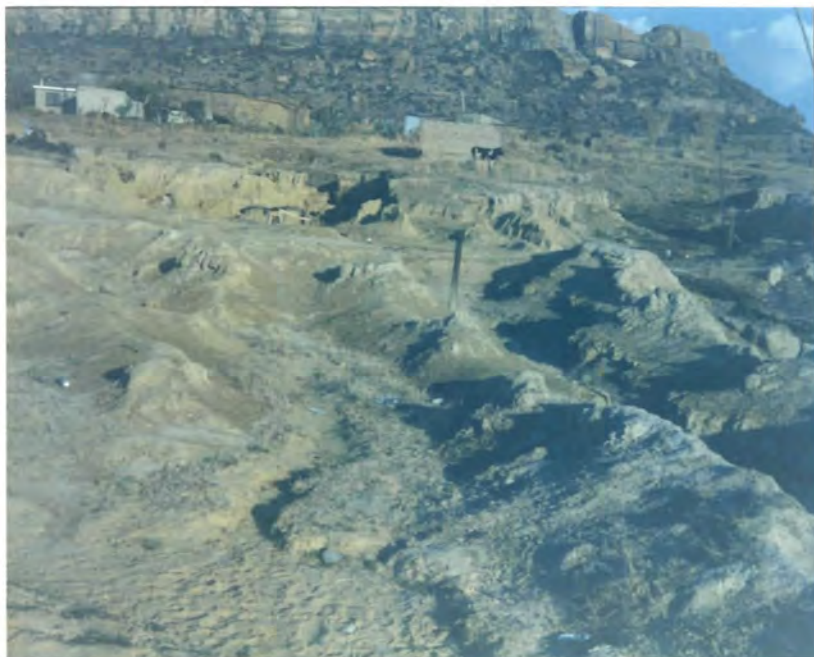
Plate 8 Parallel footpaths and rills developing into gullies.

Footpaths are present in large parts of the settled area, in between settlements, along and between long winding roads. Footpaths have been observed to develop into rills which displace the original footpath a few metres from its original course. This displacement of footpaths like that of roads (Sheddick, 1954), results in the formation of parallel footpaths. Consequently a large number of footpaths develop into deep rills or even gullies creating a badland, Plate 8. It should be noted that roads and footpaths are conducive to high runoff generation, hence the association with gullying rather than sheetwash. Roads therefore enhance transport due to increased drainage capacity.

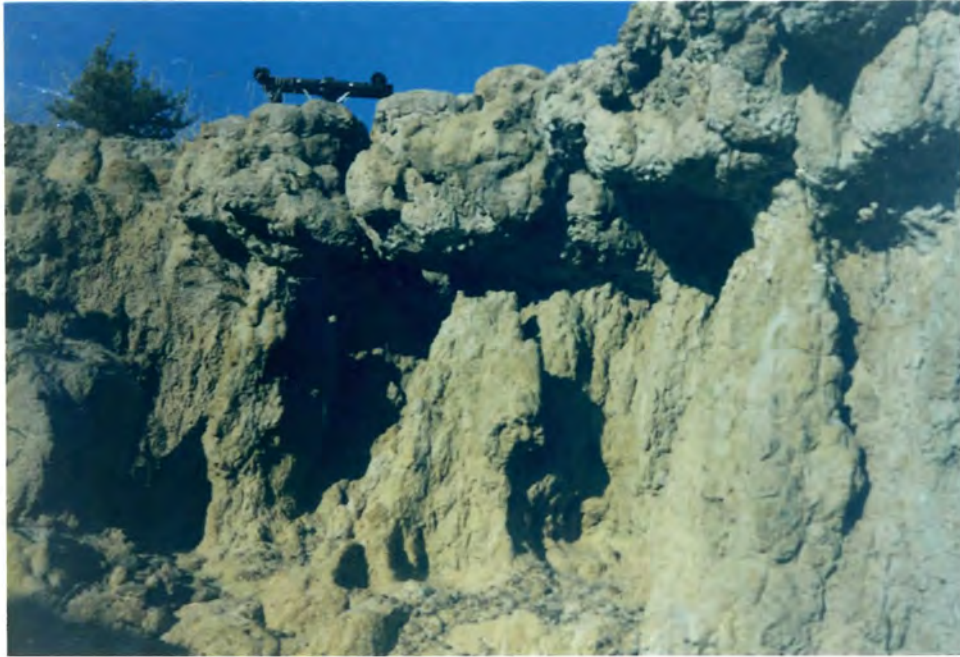
Plate 9 Gully wall showing undercutting of the subsoil.

Sediment from gullies also comes from gully walls which are constantly eroding due to undercutting. Wide U-shaped gullies are a common feature of duplex soils in Lesotho (Rooyani, 1982a). These gullies result from undercutting of the compact and less resistant substratum, and the subsequent slumping of the resistant capping. Stages in the undercutting process leading to the formation of U-shaped gullies are shown in Plates 9 and 10.

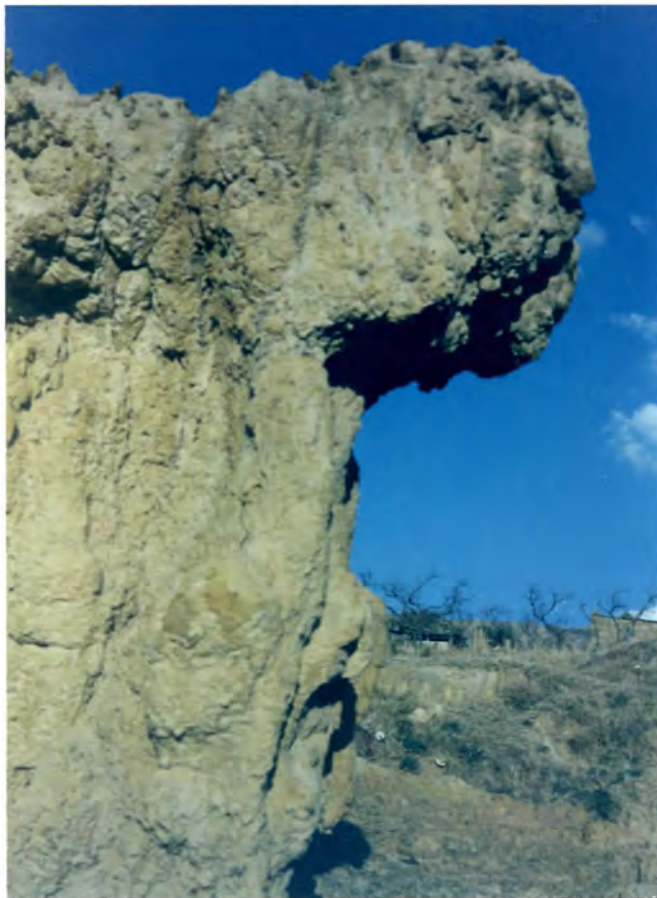
Plate 10 Gully wall showing the resistant top soil capping.

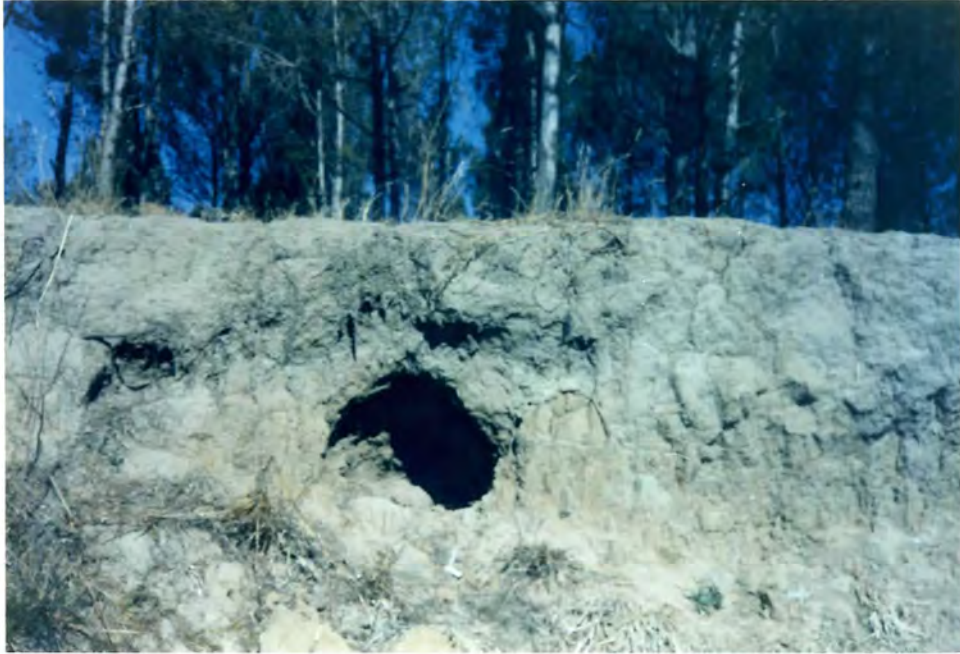
Plate 11 A pipe outlet on gully wall.

The erodibility of duplex soils of Lesotho has been described by Schmitz (1980), Rooyani (1981) and Faber and Imeson (1982) who suggested that the physical properties of the soil create an opportunity for pipe formation. Pipes were observed on some of the gully walls in the valley bottom, as shown in Plates 11 and 12. Pipe roof collapse was observed in gully No. 2, (Table 28). This gully has two branches, both of which seem to have developed through pipe roof collapse. The inter-branch area remains intact while the branches are connected by several tunnels about 30 to 40cm in height. Piping has been reported in other areas of Lesotho in studies such as those by Schmitz (1980) and Chakela (1981), who noted that pipe roof collapse was responsible for the initiation of new gullies.

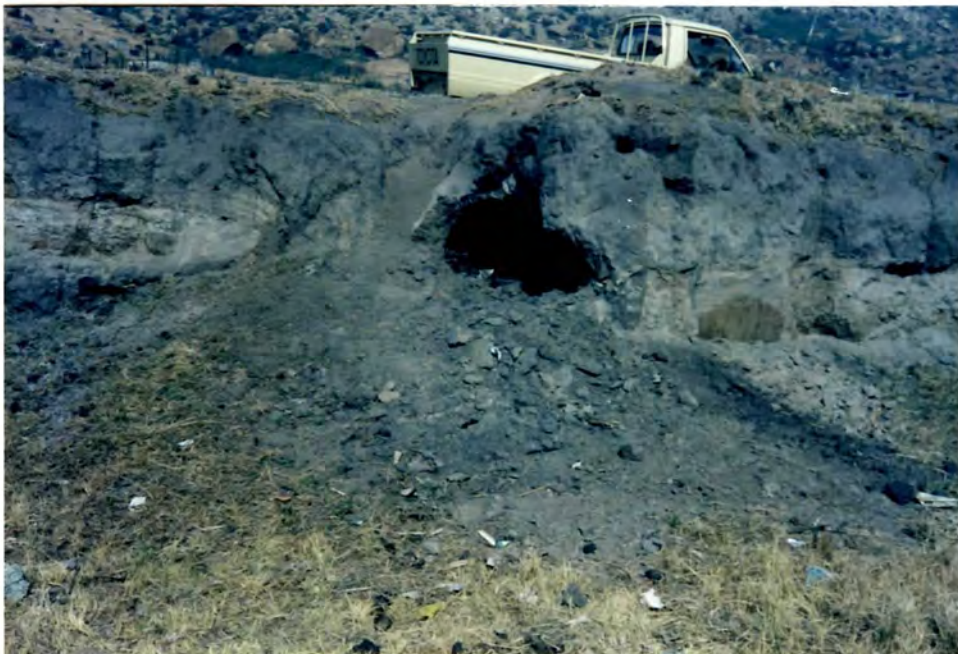
Plate 12 A pipe outlet; loose sediment is being removed from the pipe for purposes of building.

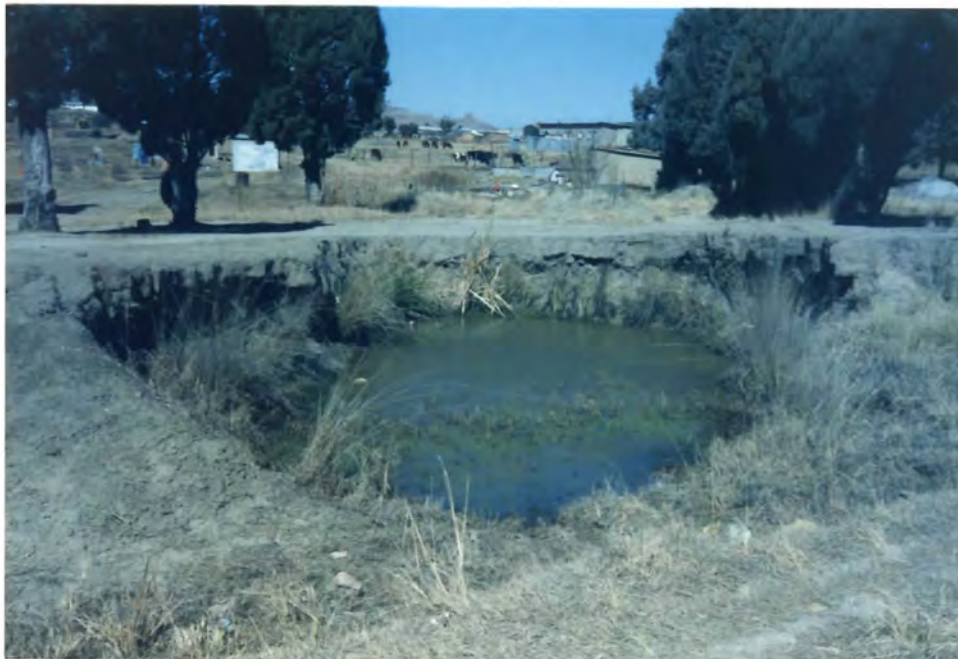
Plate 14 Brickmaking pit.

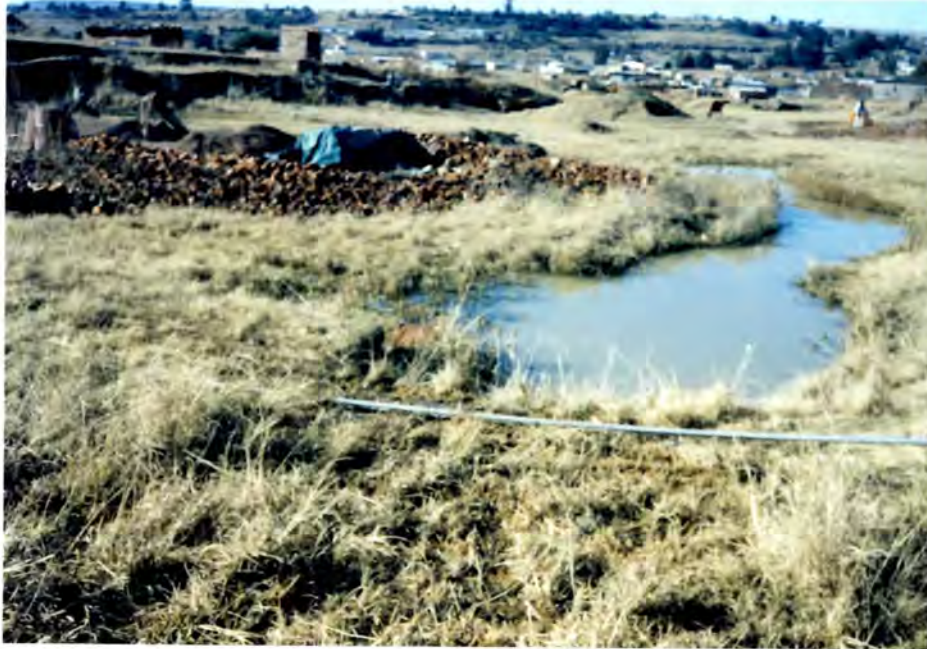
Plate 15 Two pits coalesce to form a long pond.

In other areas burrow pits are neither protected nor restored during and after extraction. These pits are situated on relatively flat land downslope of a steep debris slope and act as traps for runoff coming from upslope. The walls of the pit become saturated with water while the surface around the pit is covered with vegetation as shown in Plate 14. Undermining of the walls occurs, followed by slumping of the vegetated and relatively resistant capping. The pit increases in surface area resulting in a shallow pond with deposition of sediment at the bottom. A typical pit measured in the field was about 1,8m deep, and about 2 to 3m² in surface area (Plate 14). At this depth soils are more compact than at the top, and digging becomes difficult. The pit is then abandoned for a new one a few metres away from the old one. The process continues until part of the slope is covered with numerous pits collecting water from upslope. In some instances the narrow strip of land between two adjacent pits collapses due to the pressure of water in the upslope pit. The two or more pits coalesce to form a long pond that progressively grows into a channel leading to the reservoir (Plate 15).

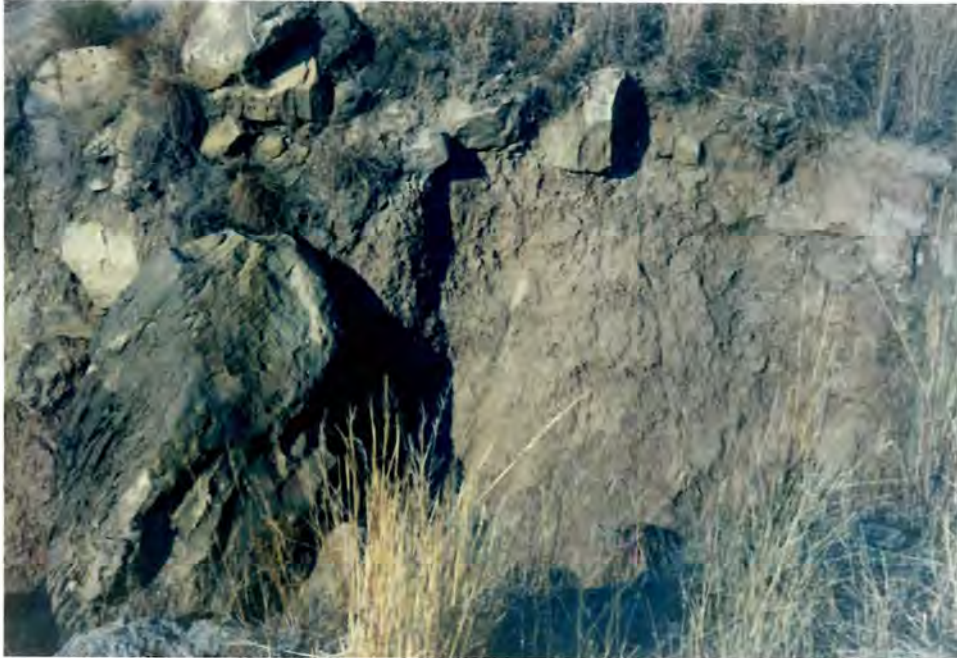
Plate 17 Sandstone boulders protecting gully head.

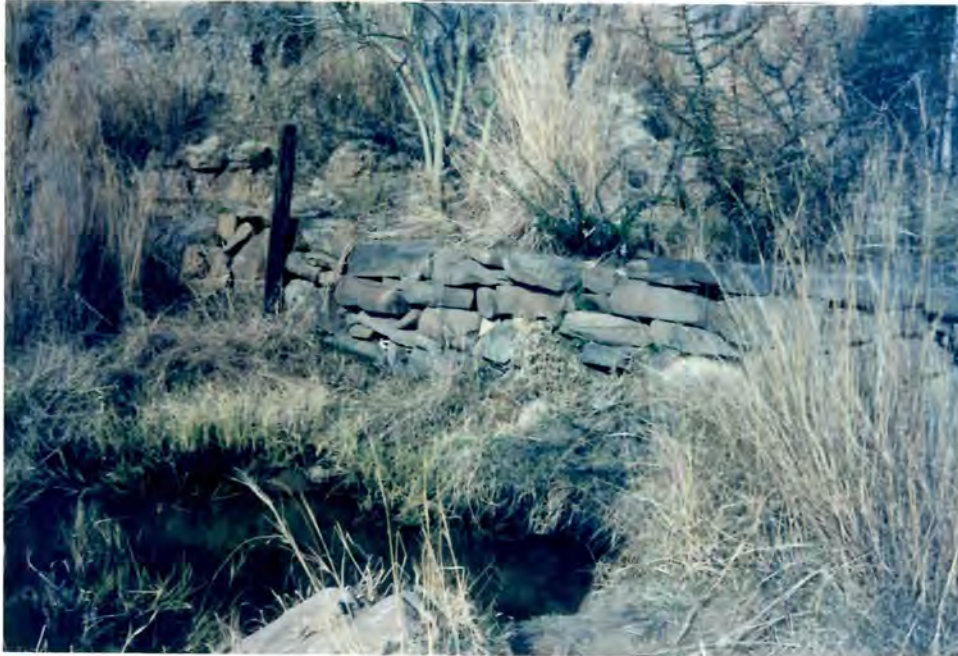
Plate 18 Check dam within gully.

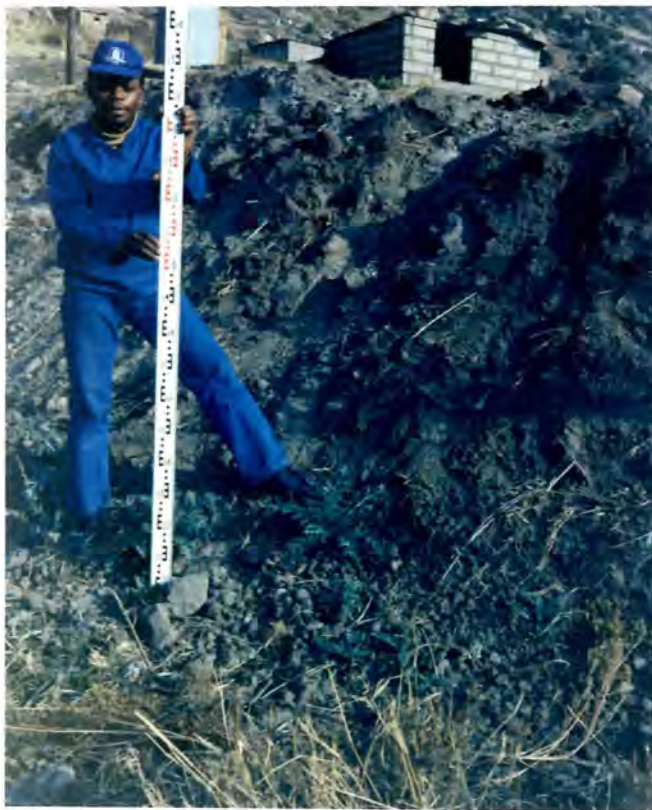
Plate 19 Gully filled with loose sediment from a construction site.
